Access Compliance Report

Public Rights-of-Way

(Curb Ramps)

Intersection ID: 42838	Main Street: SARDIS_OAKS_RD	Cross Street: SARDIS_RD_NORTH	Location: NW
ADA ID: F407CE9B0643	Ramp Type: Para	Initial Pass/Fail: Fail	Overall Compliance: No
		Severity Score: 12.5

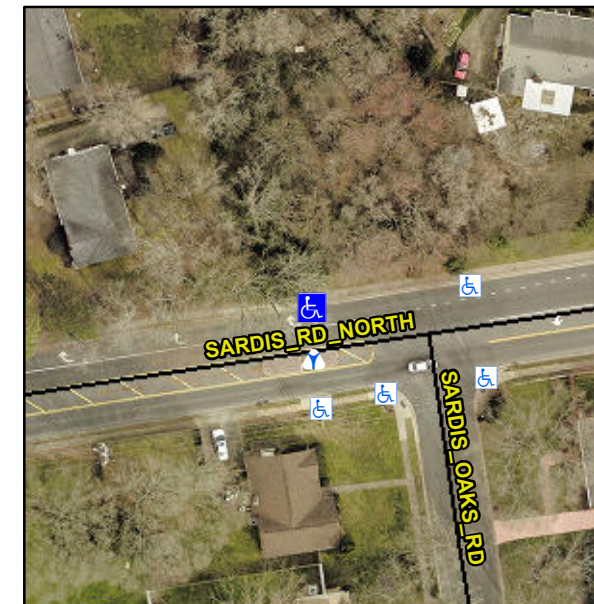
Compliance	Description	Data	Compliance	Description	Data
N/A	Ramp Length LT (in)	75.0	N/A	Ramp Length RT (in)	72.0
Yes	Ramp Width LT (in)	64.0	Yes	Ramp Width RT (in)	61.0
No	Ramp Slope LT (%)	9.0	Yes	Ramp Slope RT (%)	6.6
Yes	Ramp XSlope LT (%)	0.4	Yes	Ramp XSlope RT (%)	0.7
N/A	Landing Length (in)	N/A	N/A	DWS Provided?	N/A
N/A	Landing Width (in)	N/A	N/A	DWS Contrast?	N/A
N/A	Landing Slope (%)	N/A	N/A	DWS Length (in)	N/A
N/A	Landing X Slope (%)	N/A	N/A	DWS Full Width?	N/A
N/A	Landing Curb? (Y/N)	N/A	N/A	DWS Offset (in)	N/A
N/A	Shared Landing?	N/A			
N/A	Gutter Ponding?	N/A	N/A	Gutter Slope (%)	N/A
N/A	Gutter Lip Ht (in)	N/A	N/A	Gutter X Slope (%)	N/A
N/A	Painted X Walk1?	No	N/A	Painted X Walk2?	N/A
	X Walk 1 Direction	To S		X Walk 2 Direction	N/A
N/A	X Walk 1 Width (in)	N/A	N/A	X Walk 2 Width (in)	N/A
	X Walk 1 Slope (%)	3.9		X Walk 2 Slope (%)	N/A
	X Walk 1 X Slope (%)	0.9		X Walk 2 X Slope (%)	N/A
N/A	Ramp inside XWalk1?	N/A	N/A	Ramp inside XWalk2?	N/A

Road Slope (%)	N/A	N/A	Clear Space?	N/A
	Road X Slope (%)	N/A	N/A	Clear Space to XWalk (in)	N/A
N/A	Any Obstructions?	N/A	N/A	Storm Grate/Utility Hazard?	N/A
	Obstruction Type			Storm Grate/Utility Type	
		N/A			N/A
			Yes	Surface Condition? (G/P)	Good
			N/A	Curb Slope (%)	10.4

Remove & Replace Entire Ramp.
