## **Access Compliance Report Public Rights-of-Way** (Curb Ramps)

Intersection ID: 10018631 Main Street: AGAVA\_LN **Cross Street: N/A** Location: NW Initial Pass/Fail: Fail **Overall Compliance: No ADA ID: F41E997BAD8B** Ramp Type: Perp **Severity Score:** 22.5

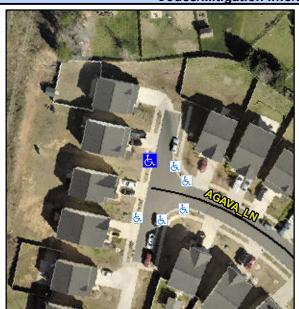
No	Ramp Width (in)	47.5	Yes	Ramp XSlope (%)	4.9
N/A	Flare Type LT	N/A	N/A	Flare Type RT	N/A
N/A	Flare Slope LT (%)	N/A	N/A	Flare Slope RT (%)	N/A
N/A	Flare Traversable LT?	N/A	N/A	Flare Traversable RT?	N/A
N/A	Landing Length (in)	N/A	N/A	DWS Provided?	N/A
N/A	Landing Width (in)	N/A	N/A	DWS Contrast?	N/A
N/A	Landing Slope (%)	N/A	N/A	DWS Length (in)	N/A
N/A	Landing X Slope (%)	N/A	N/A	DWS Full Width?	N/A
N/A	Landing Curb? (Y/N)	N/A	N/A	DWS Offset (in)	N/A
N/A	Shared Landing?	N/A			
N/A	Gutter Ponding?	N/A	N/A	Gutter Slope (%)	N/A
N/A	Gutter Lip Ht (in)	N/A	N/A	Gutter X Slope (%)	N/A
N/A	Painted X Walk1?	No	N/A	Painted X Walk2?	N/A
	X Walk 1 Direction	То Е		X Walk 2 Direction	N/A
N/A	X Walk 1 Width (in)	N/A	N/A	X Walk 2 Width (in)	N/A
	X Walk 1 Slope (%)	1.6		X Walk 2 Slope (%)	N/A
	X Walk 1 X Slope (%)	6.6		X Walk 2 X Slope (%)	N/A
N/A	Ramp inside XWalk1?	N/A	N/A	Ramp inside XWalk2?	N/A
	Road Slope (%)	N/A	N/A	Clear Space?	N/A

Road X Slope (%)	N/A	N/A	Clear Space to XWalk (in)	N/A
N/A	Any Obstructions?	N/A	N/A	Storm Grate/Utility Hazard?	N/A
	Obstruction Type			Storm Grate/Utility Type	
		N/A			N/A
			Yes	Surface Condition? (G/P)	Good
1

COCIDIO COIGLIOII		i ioia iiio	
Possible Solutions:	Compl	iance Description	
Remove & Replace Entire Ramp.	N/A	Ramp Length (in) Ramp Width (in) Flare Type LT	
·	No		
	N/A		
	N/A	Flare Slope LT (%)	
	N/A	Flare Traversable LT	
	N/A	Landing Length (in)	
Surveyor Notes:	N/A	Landing Width (in)	
N/A	N/A	Landing Slope (%)	
	N/A	Landing X Slope (%)	
	N/A	Landing Curb? (Y/N)	
	N/A	Shared Landing?	
PROW/ADA:	N/A	Gutter Ponding?	
Not Found, R304.5.1, R304.2.2	N/A	Gutter Lip Ht (in)	
·	N/A	Painted X Walk1?	
		X Walk 1 Direction	
	N/A	X Walk 1 Width (in)	
		X Walk 1 Slope (%)	
		X Walk 1 X Slope (%	
	N/A	Ramp inside XWalk1	
		Road Slope (%)
