Access Compliance Report

Public Rights-of-Way

(Curb Ramps)

Intersection ID: 17229	Main Street: LOMAX_AV	Cross Street: BLOOMDALE_DR	Location: SW
ADA ID: F427EDEAA8E3	Ramp Type: Para	Initial Pass/Fail: Fail	Overall Compliance: No
		Severity Score: 22.5

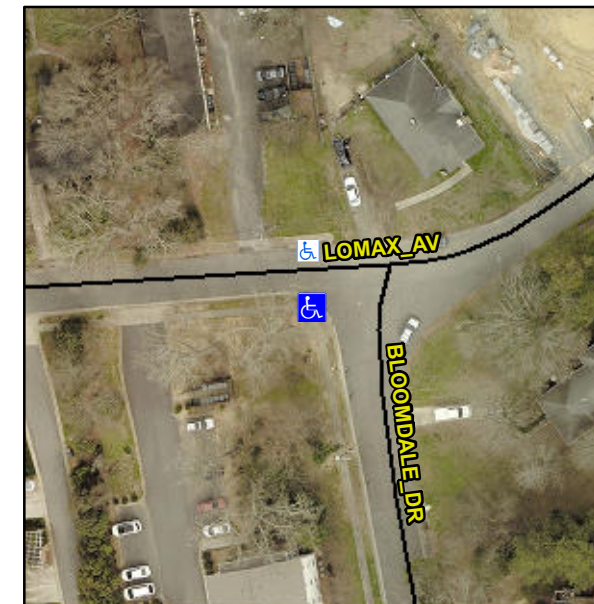
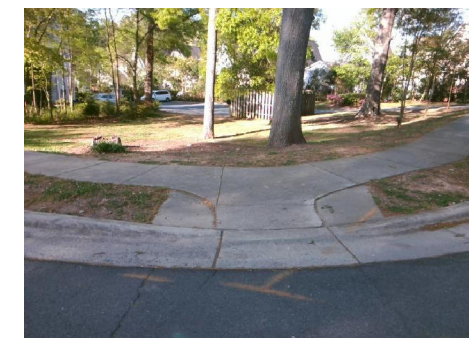
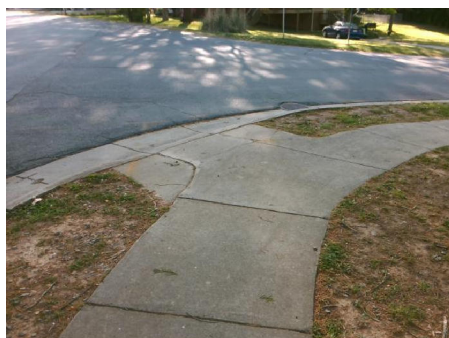
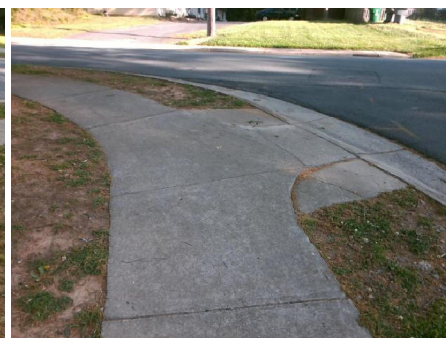
Compliance	Description	Data	Compliance	Description	Data
N/A	Ramp Length LT (in)	46.0	N/A	Ramp Length RT (in)	53.5
No	Ramp Width LT (in)	47.0	No	Ramp Width RT (in)	47.0
Yes	Ramp Slope LT (%)	5.8	No	Ramp Slope RT (%)	10.8
No	Ramp XSlope LT (%)	2.4	No	Ramp XSlope RT (%)	3.1
N/A	Landing Length (in)	N/A	N/A	DWS Provided?	N/A
N/A	Landing Width (in)	N/A	N/A	DWS Contrast?	N/A
N/A	Landing Slope (%)	N/A	N/A	DWS Length (in)	N/A
N/A	Landing X Slope (%)	N/A	N/A	DWS Full Width?	N/A
N/A	Landing Curb? (Y/N)	N/A	N/A	DWS Offset (in)	N/A
N/A	Shared Landing?	N/A			
N/A	Gutter Ponding?	N/A	N/A	Gutter Slope (%)	N/A
N/A	Gutter Lip Ht (in)	N/A	N/A	Gutter X Slope (%)	N/A
N/A	Painted X Walk1?	No	N/A	Painted X Walk2?	N/A
	X Walk 1 Direction	To N		X Walk 2 Direction	N/A
N/A	X Walk 1 Width (in)	N/A	N/A	X Walk 2 Width (in)	N/A
	X Walk 1 Slope (%)	5.7		X Walk 2 Slope (%)	N/A
	X Walk 1 X Slope (%)	0.4		X Walk 2 X Slope (%)	N/A
N/A	Ramp inside XWalk1?	N/A	N/A	Ramp inside XWalk2?	N/A

Road Slope (%)	N/A	N/A	Clear Space?	N/A
	Road X Slope (%)	N/A	N/A	Clear Space to XWalk (in)	N/A
N/A	Any Obstructions?	N/A	N/A	Storm Grate/Utility Hazard?	N/A
	Obstruction Type			Storm Grate/Utility Type	
		N/A			N/A
			Yes	Surface Condition? (G/P)	Good
			N/A	Curb Slope (%)	7.5

Remove & Replace Entire Ramp.

R304.5.1, R304.5.3, R304.3.2
