# Access Compliance Report

## Public Rights-of-Way

| Intersection ID: 14617 | Main Street: BALTIMORE_AV | Cross Street: REMOUNT_RD | Location: | S |
| ADA ID: F42808B13542 | Ramp Type: PerpDiag | Initial Pass/Fail: Fail | Overall Compliance: No | Severity Score: 22.5 |

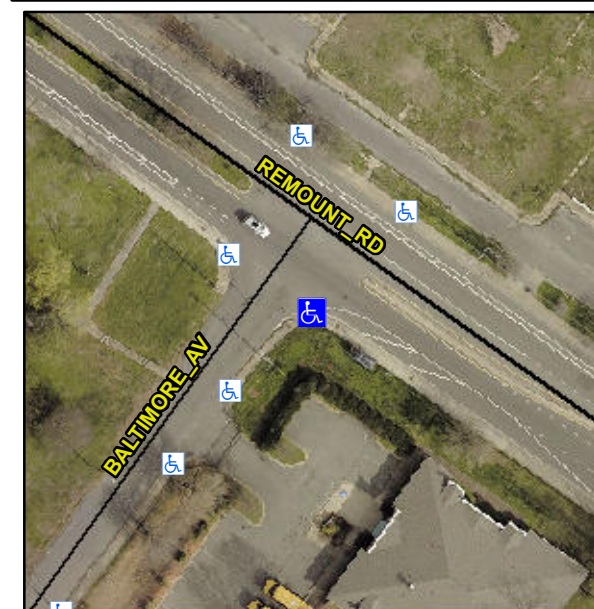
**Not Found, R304.5.1, R304.2.2, R304.5.3**

| Compliance | Description | Data | Compliance | Description | Data |
|---|---|---|---|---|---|
| N/A | Ramp Length (in) | 60.0 | No | Ramp Slope (%) | 8.8 |
| No | Ramp Width (in) | 37.0 | No | Ramp XSlope (%) | 3.2 |

**Remove & Replace Curb Ramp With Two New Directional Ramps or Equivalent.**

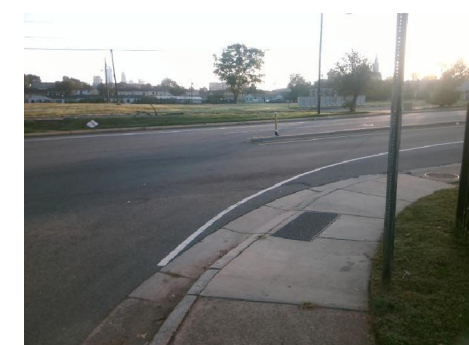
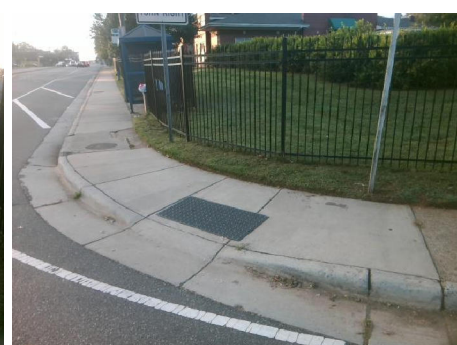
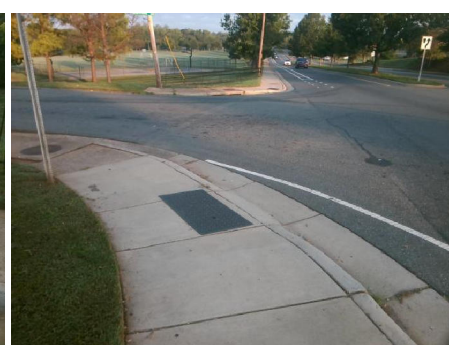
| Compliance | Description | Data | Compliance | Description | Data |
|---|---|---|---|---|---|
| | | | Yes | Surface Condition? (G/P) | Good |
