Access Compliance Report

Public Rights-of-Way

(Curb Ramps)

Intersection ID: 10011809	Main Street: STATESVILLE_RD	Cross Street: N/A	Location: NE
ADA ID: F447C6C05F1F	Ramp Type: Perp	Initial Pass/Fail: Fail	Overall Compliance: No
Severity Score: 8.75			
Codes/Mitigation Info/Possible Solution		Field Measurements/Component Compliance

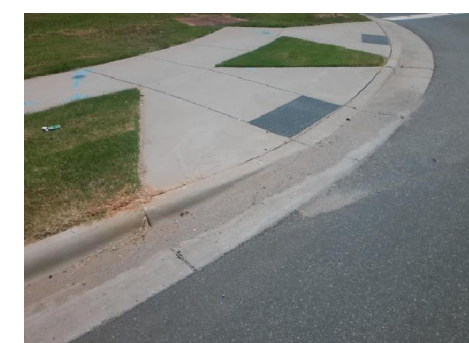
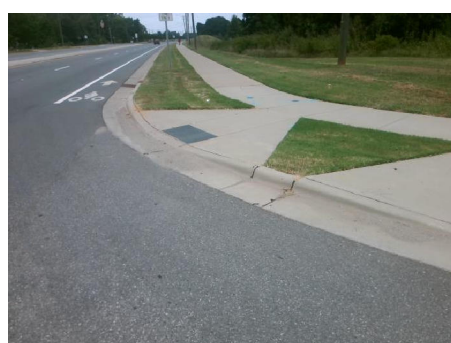
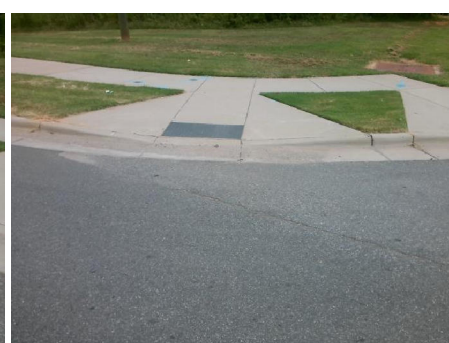
Compliance	Description	Data	Compliance	Description	Data
N/A	Ramp Length (in)	104.0	Yes	Ramp Slope (%)	6.3
No	Ramp Width (in)	47.0	Yes	Ramp XSlope (%)	0.0
N/A	Flare Type LT	N/A	N/A	Flare Type RT	N/A
N/A	Flare Slope LT (%)	N/A	N/A	Flare Slope RT (%)	N/A
N/A	Flare Traversable LT?	N/A	N/A	Flare Traversable RT?	N/A
N/A	Landing Length (in)	N/A	N/A	DWS Provided?	N/A
N/A	Landing Width (in)	N/A	N/A	DWS Contrast?	N/A
N/A	Landing Slope (%)	N/A	N/A	DWS Length (in)	N/A
N/A	Landing X Slope (%)	N/A	N/A	DWS Full Width?	N/A
N/A	Landing Curb? (Y/N)	N/A	N/A	DWS Offset (in)	N/A
N/A	Shared Landing?	N/A			
N/A	Gutter Ponding?	N/A	N/A	Gutter Slope (%)	N/A
N/A	Gutter Lip Ht (in)	N/A	N/A	Gutter X Slope (%)	N/A
N/A	Painted X Walk1?	No	N/A	Painted X Walk2?	N/A
	X Walk 1 Direction	To W		X Walk 2 Direction	N/A
N/A	X Walk 1 Width (in)	N/A	N/A	X Walk 2 Width (in)	N/A
	X Walk 1 Slope (%)	0.5		X Walk 2 Slope (%)	N/A
	X Walk 1 X Slope (%)	1.4		X Walk 2 X Slope (%)	N/A

N/A	Ramp inside XWalk1?	N/A	N/A	Ramp inside XWalk2?	N/A
	Road Slope (%)	N/A	N/A	Clear Space?	N/A
	Road X Slope (%)	N/A	N/A	Clear Space to XWalk (in)	N/A
N/A	Any Obstructions?	N/A	N/A	Storm Grate/Utility Hazard?	N/A
	Obstruction Type			Storm Grate/Utility Type	
		N/A			N/A
			Yes	Surface Condition? (G/P)	Good

Possible Solutions:

Remove & Replace Entire Ramp.
