Access Compliance Report

Public Rights-of-Way (Curb Ramps)

Intersection ID: 2787	Main Street: RIDGE_PEAK_CT	Cross Street: SKYLINE_DR	Location: SE
ADA ID: F448DC7C56AD	Ramp Type: PerpDiag	Initial Pass/Fail: Fail	Overall Compliance: No
Codes/Mitigation Info/Possible Solution		Field Measurements/Component Compliance	
Severity Score: 22.5

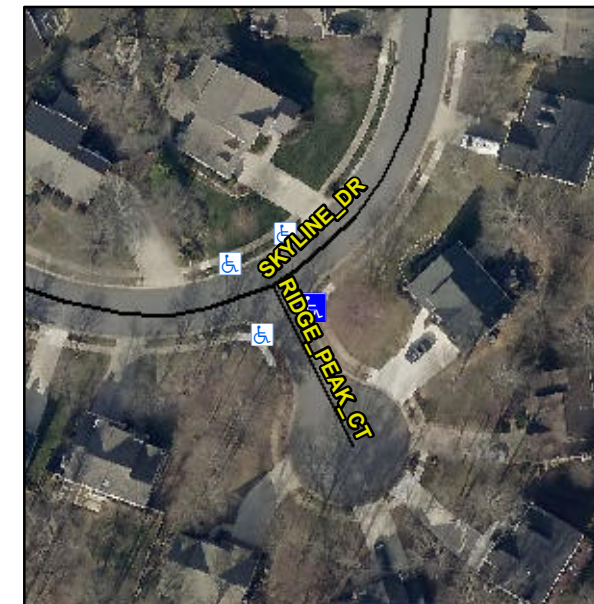
Not Found, R304.5.1, R304.2.2, R304.5.3

Compliance	Description	Data	Compliance	Description	Data
N/A	Ramp Length (in)	48.0	No	Ramp Slope (%)	9.0
No	Ramp Width (in)	39.0	No	Ramp XSlope (%)	3.7
N/A	Flare Type LT	N/A	N/A	Flare Type RT	N/A
N/A	Flare Slope LT (%)	N/A	N/A	Flare Slope RT (%)	N/A
N/A	Flare Traversable LT?	N/A	N/A	Flare Traversable RT?	N/A
N/A	Landing Length (in)	N/A	N/A	DWS Provided?	N/A
N/A	Landing Width (in)	N/A	N/A	DWS Contrast?	N/A
N/A	Landing Slope (%)	N/A	N/A	DWS Length (in)	N/A
N/A	Landing X Slope (%)	N/A	N/A	DWS Full Width?	N/A
N/A	Landing Curb? (Y/N)	N/A	N/A	DWS Offset (in)	N/A
N/A	Shared Landing?	N/A			
N/A	Gutter Ponding?	N/A	N/A	Gutter Slope (%)	N/A
N/A	Gutter Lip Ht (in)	N/A	N/A	Gutter X Slope (%)	N/A
N/A	Painted X Walk1?	No	N/A	Painted X Walk2?	No
	X Walk 1 Direction	To N		X Walk 2 Direction	To W
N/A	X Walk 1 Width (in)	N/A	N/A	X Walk 2 Width (in)	N/A
	X Walk 1 Slope (%)	1.0		X Walk 2 Slope (%)	1.7
	X Walk 1 X Slope (%)	2.3		X Walk 2 X Slope (%)	2.9

N/A	Ramp inside XWalk1?	N/A	N/A	Ramp inside XWalk2?	N/A
	Road Slope (%)	2.3	N/A	Clear Space?	N/A
	Road X Slope (%)	0.4	N/A	Clear Space to XWalk (in)	N/A
N/A	Any Obstructions?	N/A	N/A	Storm Grate/Utility Hazard?	N/A
	Obstruction Type			Storm Grate/Utility Type	
		N/A			N/A
			Yes	Surface Condition? (G/P)	Good

Remove & Replace Curb Ramp With Two New Directional Ramps or Equivalent.

Total Cost: \$ 3200.00
