# Access Compliance Report

## Public Rights-of-Way

### (Curb Ramps)

Intersection ID: 4578	Main Street: OLD_STATESVILLE_RD	Cross Street: HOLLY_VISTA_AV	Location: SW
ADA ID: F4524F1172D4	Ramp Type: Perp	Initial Pass/Fail: Fail	Overall Compliance: No
Severity Score: 22.5			
Codes/Mitigation Info/Possible Solution		Field Measurements/Component Compliance

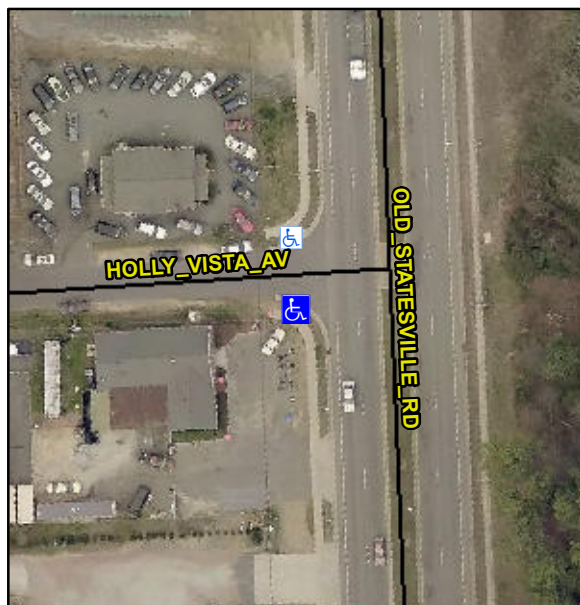
**Not Found, R304.5.1, R304.2.2, R304.5.3**

Compliance	Description	Data	Compliance	Description	Data
N/A	Ramp Length (in)	60.0	No	Ramp Slope (%)	11.1
No	Ramp Width (in)	38.0	No	Ramp XSlope (%)	2.4
N/A	Flare Type LT	N/A	N/A	Flare Type RT	N/A
N/A	Flare Slope LT (%)	N/A	N/A	Flare Slope RT (%)	N/A
N/A	Flare Traversable LT?	N/A	N/A	Flare Traversable RT?	N/A
N/A	Landing Length (in)	N/A	N/A	DWS Provided?	N/A
N/A	Landing Width (in)	N/A	N/A	DWS Contrast?	N/A
N/A	Landing Slope (%)	N/A	N/A	DWS Length (in)	N/A
N/A	Landing X Slope (%)	N/A	N/A	DWS Full Width?	N/A
N/A	Landing Curb? (Y/N)	N/A	N/A	DWS Offset (in)	N/A
N/A	Shared Landing?	N/A			
N/A	Gutter Ponding?	N/A	N/A	Gutter Slope (%)	N/A
N/A	Gutter Lip Ht (in)	N/A	N/A	Gutter X Slope (%)	N/A
N/A	Painted X Walk1?	No	N/A	Painted X Walk2?	N/A
	X Walk 1 Direction	To N		X Walk 2 Direction	N/A
N/A	X Walk 1 Width (in)	N/A	N/A	X Walk 2 Width (in)	N/A
	X Walk 1 Slope (%)	0.2		X Walk 2 Slope (%)	N/A
	X Walk 1 X Slope (%)	4.3		X Walk 2 X Slope (%)	N/A

N/A	Ramp inside XWalk1?	N/A	N/A	Ramp inside XWalk2?	N/A
	Road Slope (%)	N/A	N/A	Clear Space?	N/A
	Road X Slope (%)	N/A	N/A	Clear Space to XWalk (in)	N/A
N/A	Any Obstructions?	N/A	N/A	Storm Grate/Utility Hazard?	N/A
	Obstruction Type			Storm Grate/Utility Type	
		N/A			N/A
			Yes	Surface Condition? (G/P)	Good

Possible Solutions:

**Remove & Replace Entire Ramp.**
