Access Compliance Report

Public Rights-of-Way

(Curb Ramps)

Intersection ID: 31569	Main Street: ARVIN_DR	Cross Street: CROSS_ST	Location:	N
ADA ID: F4557614306C	Ramp Type: Combination1	Initial Pass/Fail: Fail	Overall Compliance: No	Severity Score: 10
Codes/Mitigation Info/Possible Solution		Field Measurements/Component Compliance

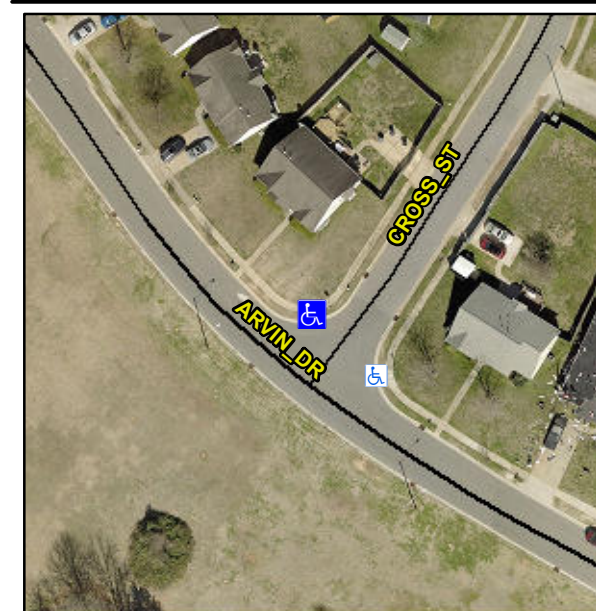
RT RP < 5%

Not Found, R304.5.1, R304.5.3

Compliance	Description	Data	Compliance	Description	Data
N/A	Ramp Length LT (in)	31.5	N/A	Ramp Length RT (in)	28.0
Yes	Ramp Width LT (in)	48.0	Yes	Ramp Width RT (in)	48.0
Yes	Ramp Slope LT (%)	5.9	Yes	Ramp Slope RT (%)	2.1
No	Ramp XSlope LT (%)	3.8	No	Ramp XSlope RT (%)	3.3
N/A	Ramp Length (in)	48.0	Yes	Ramp Slope (%)	5.2
No	Ramp Width (in)	46.0	No	Ramp XSlope (%)	3.9
N/A	Flare Type LT	N/A	N/A	Flare Type RT	N/A
N/A	Flare Slope LT (%)	N/A	N/A	Flare Slope RT (%)	N/A
N/A	Flare Traversable LT?	N/A	N/A	Flare Traversable RT?	N/A
N/A	Landing Length (in)	N/A	N/A	DWS Provided?	N/A
N/A	Landing Width (in)	N/A	N/A	DWS Contrast?	N/A
N/A	Landing Slope (%)	N/A	N/A	DWS Length (in)	N/A
N/A	Landing X Slope (%)	N/A	N/A	DWS Full Width?	N/A
N/A	Landing Curb? (Y/N)	N/A	N/A	DWS Offset (in)	N/A
N/A	Shared Landing?	N/A			
N/A	Gutter Ponding?	N/A	N/A	Gutter Slope (%)	N/A
N/A	Gutter Lip Ht (in)	N/A	N/A	Gutter X Slope (%)	N/A
N/A	Painted X Walk1?	No	N/A	Painted X Walk2?	N/A

Possible Solutions:

Remove & Replace Entire Ramp.

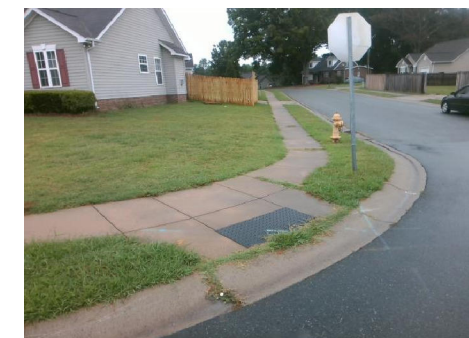
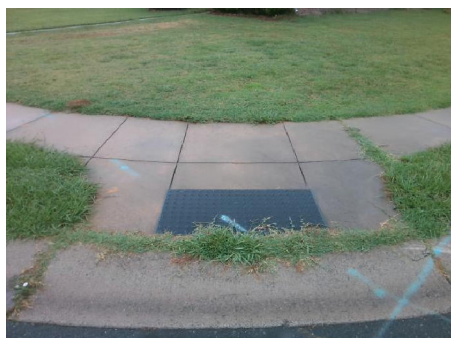
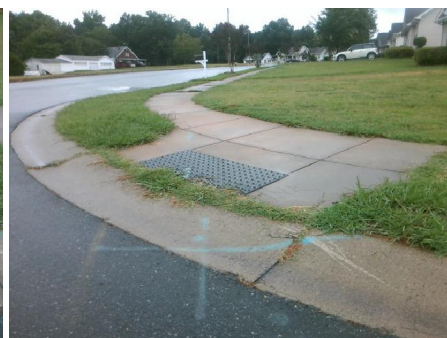
X Walk 1 Direction	To SE		X Walk 2 Direction	N/A
	X Walk 1 Width (in)	N/A		X Walk 2 Width (in)	N/A
	X Walk 1 Slope (%)	1.8		X Walk 2 Slope (%)	N/A
	X Walk 1 X Slope (%)	0.5		X Walk 2 X Slope (%)	N/A
N/A	Ramp inside XWalk1?	N/A	N/A	Ramp inside XWalk2?	N/A
	Road Slope (%)	N/A		Clear Space?	N/A
	Road X Slope (%)	N/A	N/A	Clear Space to XWalk (in)	N/A
			N/A	Any Obstruction?	N/A
				Obstruction Type	N/A
			N/A	Storm Grate/Utility Hazard?	N/A
				Storm Grate/Utility Type	N/A
			Yes	Surface Condition? (G/P)	Good
				Curb Slope (%)	14.2
