Access Compliance Report

Public Rights-of-Way

(Curb Ramps)

Intersection ID: 16115	Main Street: MARVIN_RD	Cross Street: VILLA_CT	Location: NE
ADA ID: F45587C82021	Ramp Type: PerpDiag	Initial Pass/Fail: Fail	Overall Compliance: No
Codes/Mitigation Info/Possible Solution		Field Measurements/Component Compliance	
Severity Score: 21.25

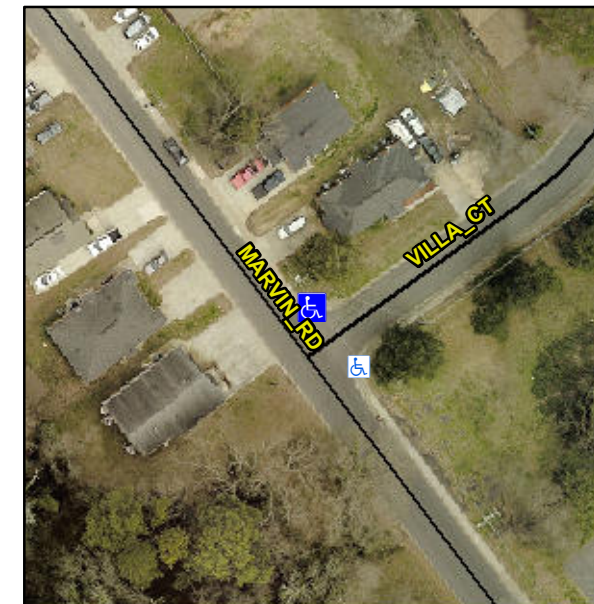
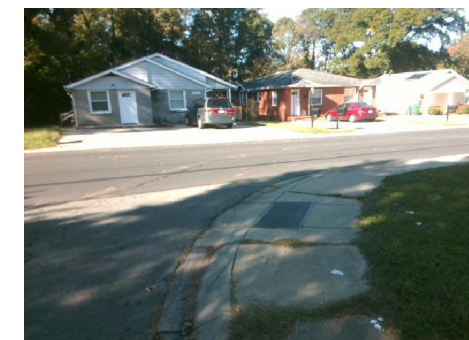
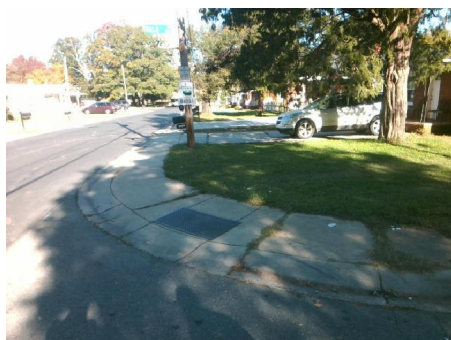
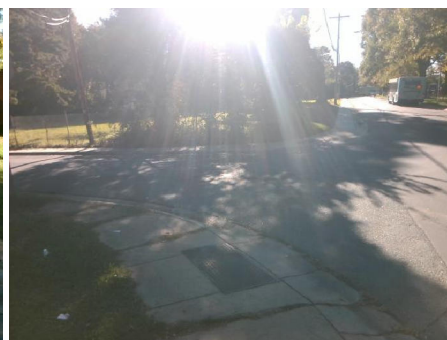
Not Found, R304.5.1, R304.2.2

Compliance	Description	Data	Compliance	Description	Data
N/A	Ramp Length (in)	28.0	No	Ramp Slope (%)	8.8
No	Ramp Width (in)	44.0	Yes	Ramp XSlope (%)	2.0
N/A	Flare Type LT	N/A	N/A	Flare Type RT	N/A
N/A	Flare Slope LT (%)	N/A	N/A	Flare Slope RT (%)	N/A
N/A	Flare Traversable LT?	N/A	N/A	Flare Traversable RT?	N/A
N/A	Landing Length (in)	N/A	N/A	DWS Provided?	N/A
N/A	Landing Width (in)	N/A	N/A	DWS Contrast?	N/A
N/A	Landing Slope (%)	N/A	N/A	DWS Length (in)	N/A
N/A	Landing X Slope (%)	N/A	N/A	DWS Full Width?	N/A
N/A	Landing Curb? (Y/N)	N/A	N/A	DWS Offset (in)	N/A
N/A	Shared Landing?	N/A			
N/A	Gutter Ponding?	N/A	N/A	Gutter Slope (%)	N/A
N/A	Gutter Lip Ht (in)	N/A	N/A	Gutter X Slope (%)	N/A
N/A	Painted X Walk1?	No	N/A	Painted X Walk2?	No
	X Walk 1 Direction	To SW		X Walk 2 Direction	To SE
N/A	X Walk 1 Width (in)	N/A	N/A	X Walk 2 Width (in)	N/A
	X Walk 1 Slope (%)	0.9		X Walk 2 Slope (%)	4.0
	X Walk 1 X Slope (%)	0.4		X Walk 2 X Slope (%)	1.6

N/A	Ramp inside XWalk1?	N/A	N/A	Ramp inside XWalk2?	N/A
	Road Slope (%)	0.6	N/A	Clear Space?	N/A
	Road X Slope (%)	1.0	N/A	Clear Space to XWalk (in)	N/A
N/A	Any Obstructions?	N/A	N/A	Storm Grate/Utility Hazard?	N/A
	Obstruction Type			Storm Grate/Utility Type	
		N/A			N/A
			Yes	Surface Condition? (G/P)	Good

Remove & Replace Curb Ramp With Two New Directional Ramps or Equivalent.
