Access Compliance Report

Public Rights-of-Way

(Curb Ramps)

Intersection ID: N/A	Main Street: YORK_CENTER	Cross Street: N/A	Location: SW
ADA ID: F461134B860B	Ramp Type: Directional2	Initial Pass/Fail: Fail	Overall Compliance: No
		Severity Score: 10

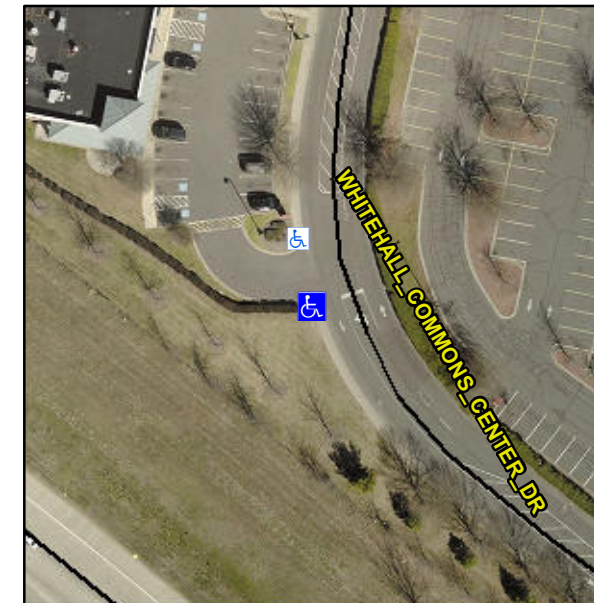
R304.5.1

Compliance	Description	Data	Compliance	Description	Data
N/A	Ramp Length (in)	53.0	N/A	Grade Break?	N/A
No	Ramp Width (in)	38.0	N/A	Grade Break Slope (%)	0.0
Yes	Ramp Slope (%)	1.4	N/A	Grade Break XSlope (%)	0.0
Yes	Ramp XSlope (%)	3.4			
N/A	Flare Type LT	N/A	N/A	Flare Type RT	N/A
N/A	Flare Slope LT (%)	N/A	N/A	Flare Slope RT (%)	0.0
N/A	Flare Traversable LT?	N/A	N/A	Flare Traversable RT?	N/A
N/A	Landing Length (in)	0.0	N/A	DWS Provided?	N/A
N/A	Landing Width (in)	0.0	N/A	DWS Contrast?	N/A
N/A	Landing Slope (%)	0.0	N/A	DWS Length (in)	N/A
N/A	Landing X Slope (%)	0.0	N/A	DWS Full Width?	N/A
N/A	Landing Curb? (Y/N)	N/A	N/A	DWS Offset LT (in)	N/A
N/A	Shared Landing?	N/A	N/A	DWS Offset RT (in)	N/A
N/A	Gutter Ponding?	0.0	N/A	Gutter Slope (%)	N/A
N/A	Gutter Lip Ht (in)	0.0	N/A	Gutter X Slope (%)	N/A
N/A	Painted X Walk1?	No		Road Slope (%)	0.1
	X Walk 1 Direction	To N		Road X Slope (%)	5.8
	X Walk 1 Width (in)	N/A		Clear Space?	N/A

X Walk 1 Slope (%)	0.1	N/A	Clear Space to XWalk (in)	N/A
	X Walk 1 X Slope (%)	5.8	N/A	Storm Grate/Utility Hazard?	N/A
N/A	Ramp inside XWalk1?	N/A		Storm Grate/Utility Type	
N/A	Any Obstructions?	N/A			N/A
	Obstruction Type		Yes	Surface Condition? (G/P)	Good
			N/A	Curb Slope (%)	13.0

Remove & Replace Entire Ramp.
