# Access Compliance Report

## Public Rights-of-Way

### (Curb Ramps)

Intersection ID: 10016274	Main Street: COMMONWEALTH_AV	Cross Street: N/A	Location:	N
ADA ID: F464BFA0726E	Ramp Type: Perp	Initial Pass/Fail: Fail	Overall Compliance: No	Severity Score: 12.5
Codes/Mitigation Info/Possible Solution		Field Measurements/Component Compliance

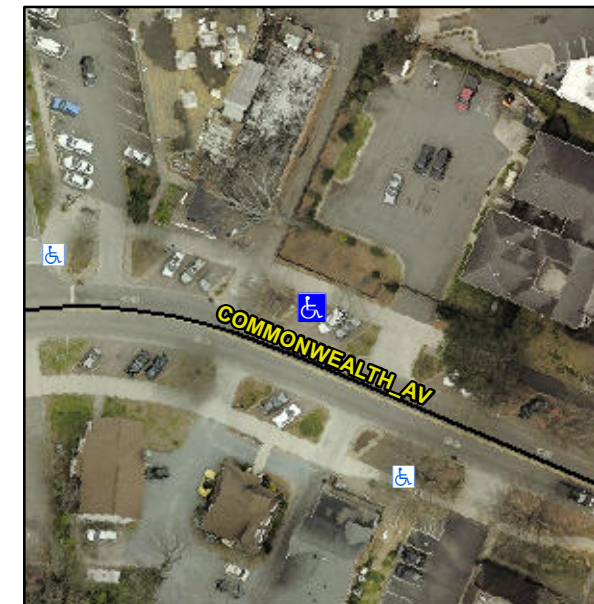
**Not Found, R304.2.2**

Compliance	Description	Data	Compliance	Description	Data
N/A	Ramp Length (in)	65.0	No	Ramp Slope (%)	9.4
Yes	Ramp Width (in)	59.0	Yes	Ramp XSlope (%)	0.8
N/A	Flare Type LT	N/A	N/A	Flare Type RT	N/A
N/A	Flare Slope LT (%)	N/A	N/A	Flare Slope RT (%)	N/A
N/A	Flare Traversable LT?	N/A	N/A	Flare Traversable RT?	N/A
N/A	Landing Length (in)	N/A	N/A	DWS Provided?	N/A
N/A	Landing Width (in)	N/A	N/A	DWS Contrast?	N/A
N/A	Landing Slope (%)	N/A	N/A	DWS Length (in)	N/A
N/A	Landing X Slope (%)	N/A	N/A	DWS Full Width?	N/A
N/A	Landing Curb? (Y/N)	N/A	N/A	DWS Offset (in)	N/A
N/A	Shared Landing?	N/A			
N/A	Gutter Ponding?	N/A	N/A	Gutter Slope (%)	N/A
N/A	Gutter Lip Ht (in)	N/A	N/A	Gutter X Slope (%)	N/A
N/A	Painted X Walk1?	No	N/A	Painted X Walk2?	N/A
	X Walk 1 Direction	To E		X Walk 2 Direction	N/A
N/A	X Walk 1 Width (in)	N/A	N/A	X Walk 2 Width (in)	N/A
	X Walk 1 Slope (%)	4.1		X Walk 2 Slope (%)	N/A
	X Walk 1 X Slope (%)	1.5		X Walk 2 X Slope (%)	N/A

N/A	Ramp inside XWalk1?	N/A	N/A	Ramp inside XWalk2?	N/A
	Road Slope (%)	N/A	N/A	Clear Space?	N/A
	Road X Slope (%)	N/A	N/A	Clear Space to XWalk (in)	N/A
N/A	Any Obstructions?	N/A	N/A	Storm Grate/Utility Hazard?	N/A
	Obstruction Type			Storm Grate/Utility Type	
		N/A			N/A
			Yes	Surface Condition? (G/P)	Good

Possible Solutions:

**Remove & Replace Entire Ramp.**

Total Cost: \$ 1850.00
