Access Compliance Report Public Rights-of-Way (Curb Ramps)

Intersection ID: 9957Main Street:ROSLYN_AVCross Street:S_SMALLWOOD_PLLocation:WADA ID: F46B38814784Ramp Type:PerpDiagInitial Pass/Fail:FailOverall Compliance:NoSeverity Score:10

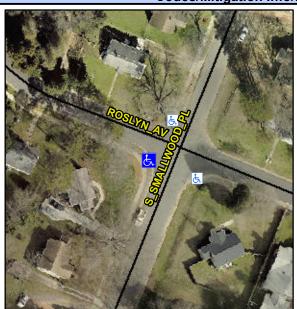
Not Found, R304.5.1, R304.5.3

Yes N/A Ramp Length (in) 69.5 Ramp Slope (%) 5.2 No Ramp XSlope (%) No Ramp Width (in) 47.5 4.2 N/A N/A Flare Type LT N/A Flare Type RT N/A N/A N/A N/A Flare Slope RT (%) N/A Flare Slope LT (%) N/A Flare Traversable LT? N/A N/A Flare Traversable RT? N/A N/A N/A N/A **DWS Provided?** N/A Landing Length (in) N/A Landing Width (in) N/A N/A **DWS Contrast?** N/A N/A N/A N/A Landing Slope (%) DWS Length (in) N/A N/A Landing X Slope (%) N/A N/A DWS Full Width? N/A N/A Landing Curb? (Y/N) N/A N/A DWS Offset (in) N/A N/A N/A Shared Landing? N/A **Gutter Ponding?** N/A N/A Gutter Slope (%) N/A N/A Gutter Lip Ht (in) 0.5 N/A Gutter X Slope (%) N/A N/A Painted X Walk1? No N/A Painted X Walk2? No X Walk 1 Direction To SE X Walk 2 Direction To NE N/A N/A X Walk 1 Width (in) X Walk 2 Width (in) N/A X Walk 1 Slope (%) X Walk 2 Slope (%) 8.4 3.8 X Walk 1 X Slope (%) 2.1 X Walk 2 X Slope (%) 6.0 N/A N/A N/A Ramp inside XWalk2? N/A Ramp inside XWalk1? Road Slope (%) 2.5 N/A Clear Space? N/A N/A Road X Slope (%) 9.3 Clear Space to XWalk (in) N/A N/A N/A N/A Any Obstructions? Storm Grate/Utility Hazard? N/A **Obstruction Type** Storm Grate/Utility Type N/A N/A Yes Surface Condition? (G/P) Good

Remove & Replace Curb Ramp With Two New Directional Ramps or Equivalent.
