# Access Compliance Report

## Public Rights-of-Way

| Intersection ID: 28659 | Main Street: HAMPTON_PLACE_DR | Cross Street: RIDGELINE_LN | Location: | N |
| ADA ID: F46C1F675C27 | Ramp Type: PerpDiag | Initial Pass/Fail: Pass | Overall Compliance: No | Severity Score: 12.5 |

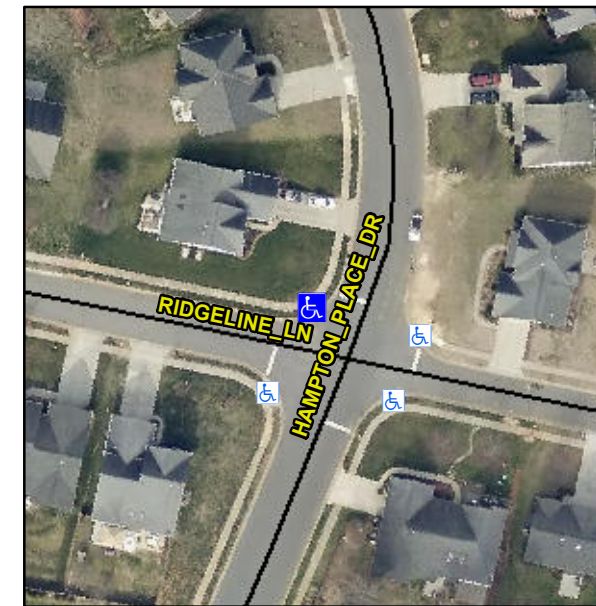
**R304.2.1, R304.2.2-Perp, R304.3.2-Para, R304.2.3, R305.1.4, R302.7, R302.7.2**

| Compliance | Description | Data | Compliance | Description | Data |
|---|---|---|---|---|---|
| No | Landing Length (in) | 45.0 | Yes | DWS Provided? | Yes |
| No | Landing Slope (%) | 4.6 | Yes | DWS Length (in) | 24.0 |
| Yes | Landing X Slope (%) | 0.6 | No | DWS Full Width? | No |
| No | Gutter Ponding? | Yes | Yes | Gutter Slope (%) | 1.9 |
| No | Gutter Lip Ht (in) | 0.5 | Yes | Gutter X Slope (%) | 1.3 |

**Remove & Replace Curb Ramp With Two New Directional Ramps or Equivalent. Grind Gutter Lip.**
