Access Compliance Report

Public Rights-of-Way

(Curb Ramps)

Intersection ID: 52929	Main Street: ENGLISH_OAK_LEAF_CT	Cross Street: GRAY_OAK_LN	Location: NE
ADA ID: F46D129B753E	Ramp Type: Perp	Initial Pass/Fail: Fail	Overall Compliance: No
Severity Score: 8.75			
Codes/Mitigation Info/Possible Solution		Field Measurements/Component Compliance

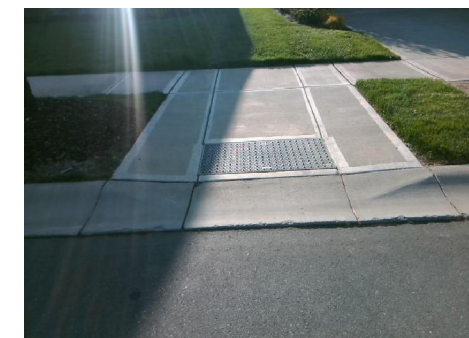
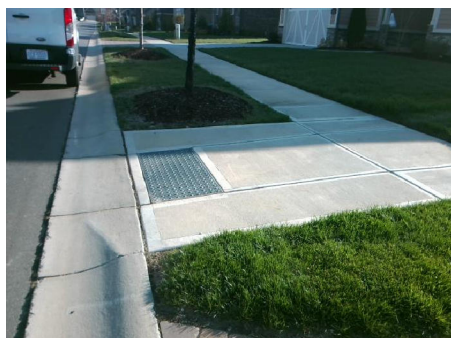
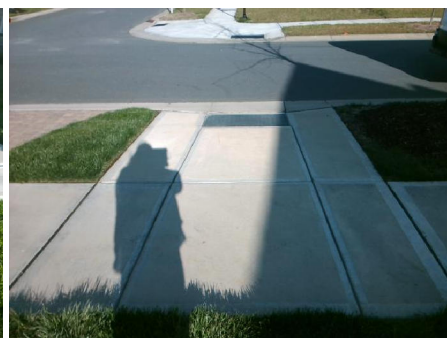
Not Found, R304.5.1

Compliance	Description	Data	Compliance	Description	Data
N/A	Ramp Length (in)	96.0	Yes	Ramp Slope (%)	5.1
No	Ramp Width (in)	47.0	Yes	Ramp XSlope (%)	0.9
N/A	Flare Type LT	N/A	N/A	Flare Type RT	N/A
N/A	Flare Slope LT (%)	N/A	N/A	Flare Slope RT (%)	N/A
N/A	Flare Traversable LT?	N/A	N/A	Flare Traversable RT?	N/A
N/A	Landing Length (in)	N/A	N/A	DWS Provided?	N/A
N/A	Landing Width (in)	N/A	N/A	DWS Contrast?	N/A
N/A	Landing Slope (%)	N/A	N/A	DWS Length (in)	N/A
N/A	Landing X Slope (%)	N/A	N/A	DWS Full Width?	N/A
N/A	Landing Curb? (Y/N)	N/A	N/A	DWS Offset (in)	N/A
N/A	Shared Landing?	N/A			
N/A	Gutter Ponding?	N/A	N/A	Gutter Slope (%)	N/A
N/A	Gutter Lip Ht (in)	N/A	N/A	Gutter X Slope (%)	N/A
N/A	Painted X Walk1?	No	N/A	Painted X Walk2?	N/A
	X Walk 1 Direction	To W		X Walk 2 Direction	N/A
N/A	X Walk 1 Width (in)	N/A	N/A	X Walk 2 Width (in)	N/A
	X Walk 1 Slope (%)	3.9		X Walk 2 Slope (%)	N/A
	X Walk 1 X Slope (%)	2.2		X Walk 2 X Slope (%)	N/A

N/A	Ramp inside XWalk1?	N/A	N/A	Ramp inside XWalk2?	N/A
	Road Slope (%)	N/A	N/A	Clear Space?	N/A
	Road X Slope (%)	N/A	N/A	Clear Space to XWalk (in)	N/A
N/A	Any Obstructions?	N/A	N/A	Storm Grate/Utility Hazard?	N/A
	Obstruction Type			Storm Grate/Utility Type	
		N/A			N/A
			Yes	Surface Condition? (G/P)	Good

Remove & Replace Entire Ramp.
