# Access Compliance Report

## Public Rights-of-Way

### (Curb Ramps)

| Intersection ID: 10025537 | Main Street: E_STONEWALL_ST | Cross Street: N/A | Location: NE |

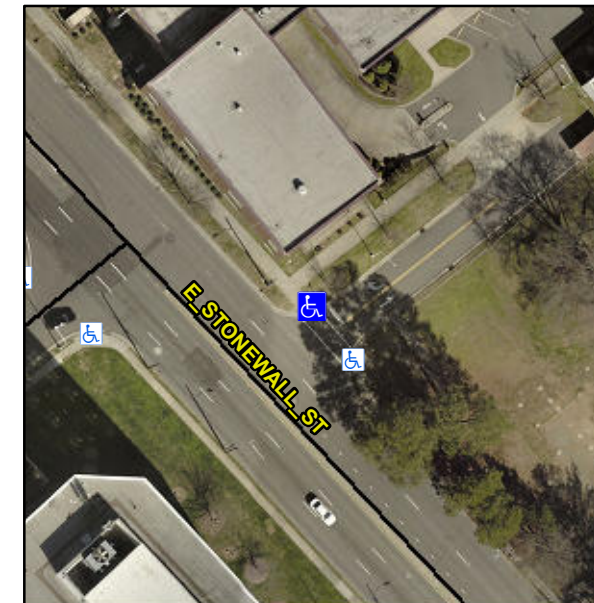
**R304.2.2, R304.5.2, R304.5.3**

| Compliance | Description | Data | Compliance | Description | Data |
|---|---|---|---|---|---|
| No | Ramp Slope (%) | 8.8 | N/A | Grade Break XSlope (%) | N/A |
| Yes | Gutter Lip Ht (in) | 0.0 | No | Gutter X Slope (%) | 4.4 |

**Remove & Replace Entire Ramp.  
Remove & Replace Gutter.**
