# Access Compliance Report

## Public Rights-of-Way

### (Curb Ramps)

| Intersection ID: 47271 | Main Street: SAVANNAH_HILLS_DR | Cross Street: LIDDINGTON_RD | Location: SW |

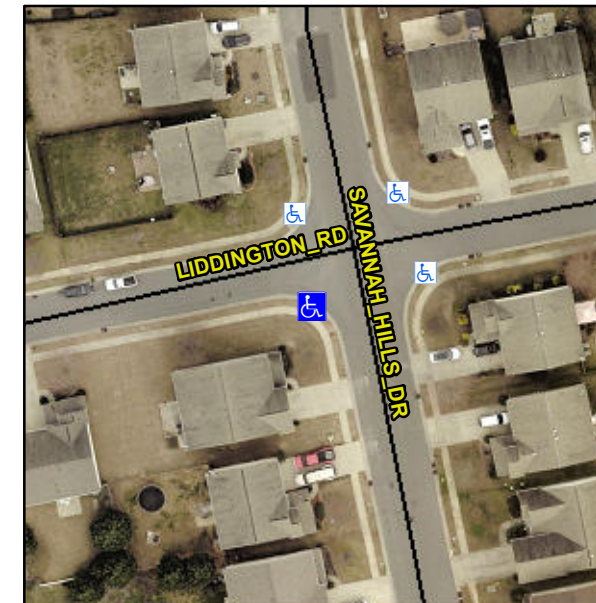
| ADA ID: F4741073CE2B | Ramp Type: BlendTrans1 | Initial Pass/Fail: Pass | Overall Compliance: No |
| | | Severity Score: 15 | |

**Not Found, R304.2.1, R305, R304.5.4**

| Compliance | Description | Data | Compliance | Description | Data |
|---|---|---|---|---|---|
| No | Landing Length (in) | 47.0 | No | DWS Provided? | No |
| Yes | Gutter Ponding? | No | No | Gutter Slope (%) | 6.7 |
| | | | No | Curb Slope (%) | 12.7 |

**Remove & Replace Curb Ramp With Two New Directional Ramps or Equivalent. Remove & Replace Gutter.**

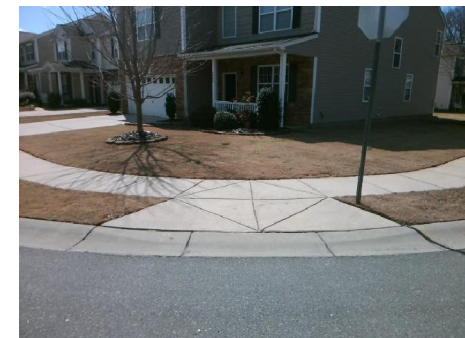
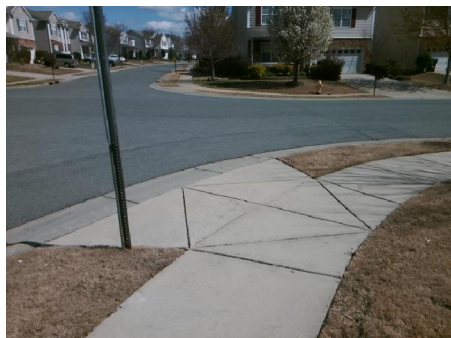
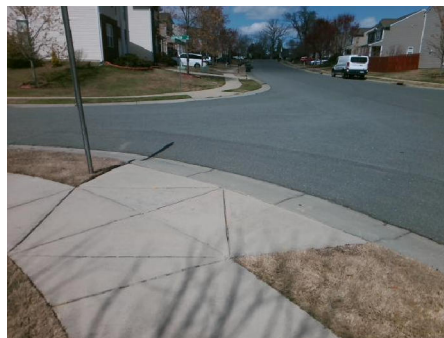
Street 1 Name SAVANNAH HILLS DR  
 Stop Condition-Street 1 None  
 Street 2 Name LIDDINGTON RD  
 Stop Condition-Street 2 StopSign
