# Access Compliance Report

## Public Rights-of-Way

### (Curb Ramps)

Intersection ID: 27815	Main Street: BRAID_HILLS_DR	Cross Street: PROVIDENCE_COUNTRY_CLUB_DR	Location: SE
ADA ID: F474E8E8F180	Ramp Type: BlendTrans2	Initial Pass/Fail: Fail	Overall Compliance: No
Severity Score: 12.5			
Codes/Mitigation Info/Possible Solution		Field Measurements/Component Compliance

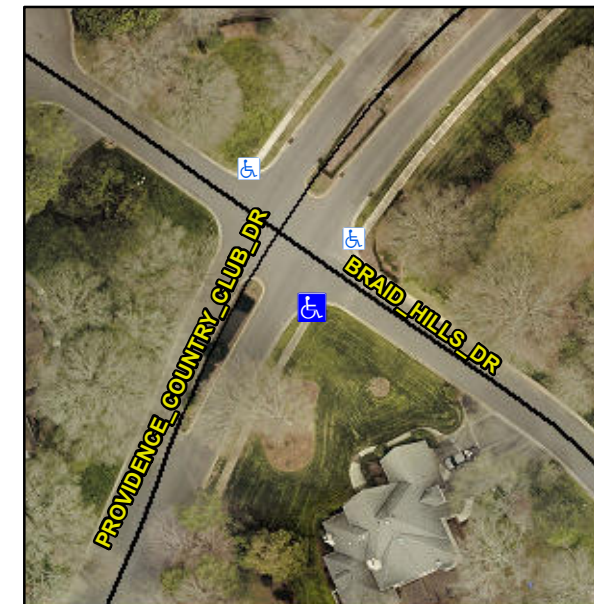
**Not Found, R304.5.3**

**Remove & Replace Curb Ramp With Two New Directional Ramps or Equivalent.**

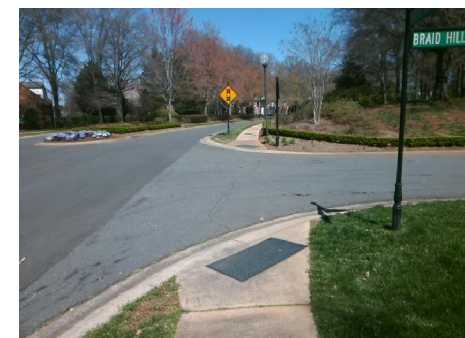
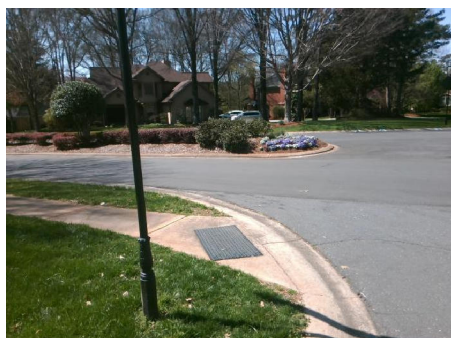
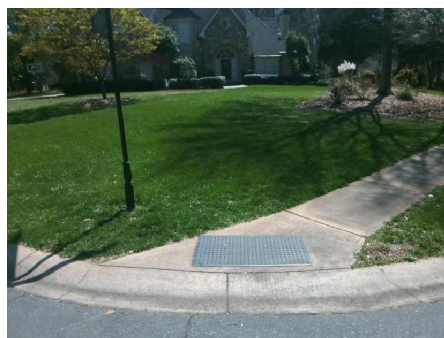
Compliance	Description	Data	Compliance	Description	Data
N/A	Ramp Length (in)	30.0	Yes	BlendTrans Slope (%)	3.6
Yes	Ramp Width (in)	48.0	No	BlendTrans XSlope (%)	6.0
N/A	Flare Type LT	N/A	N/A	Flare Type RT	N/A
N/A	Flare Slope LT (%)	N/A	N/A	Flare Slope RT (%)	N/A
N/A	Flare Traversable LT?	N/A	N/A	Flare Traversable RT?	N/A
N/A	Landing Length (in)	N/A	N/A	DWS Provided?	N/A
N/A	Landing Width (in)	N/A	N/A	DWS Contrast?	N/A
N/A	Landing Slope (%)	N/A	N/A	DWS Length (in)	N/A
N/A	Landing X Slope (%)	N/A	N/A	DWS Full Width?	N/A
N/A	Landing Curb? (Y/N)	N/A	N/A	DWS Offset (in)	N/A
N/A	Shared Landing?	N/A			
N/A	Gutter Ponding?	N/A	N/A	Gutter Slope (%)	N/A
N/A	Gutter Lip Ht (in)	N/A	N/A	Gutter X Slope (%)	N/A
N/A	Painted X Walk1?	No	N/A	Painted X Walk2?	N/A
	X Walk 1 Direction	To NE		X Walk 2 Direction	N/A
	X Walk 1 Width (in)	N/A		X Walk 2 Width (in)	N/A
	X Walk 1 Slope (%)	4.6		X Walk 2 Slope (%)	N/A
	X Walk 1 X Slope (%)	0.7		X Walk 2 X Slope (%)	N/A

N/A	Ramp inside XWalk1?	N/A	N/A	Ramp inside XWalk2?	N/A
	Road Slope (%)	0.7		Clear Space?	N/A
	Road X Slope (%)	4.6	N/A	Clear Space to XWalk (in)	N/A
N/A	Any Obstructions?	N/A	N/A	Storm Grate/Utility Hazard?	N/A
	Obstruction Type			Storm Grate/Utility Type	
		N/A			N/A
			Yes	Surface Condition? (G/P)	Good
			No	Curb Slope (%)	9.1
