# Access Compliance Report

## Public Rights-of-Way

### (Curb Ramps)

| Intersection ID: 8364 | Main Street: ENGLISH_DR | Cross Street: LASALLE_ST | Location: NW |

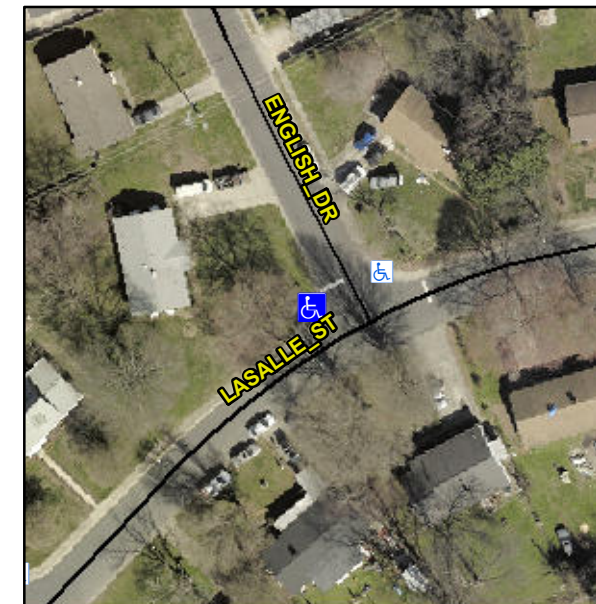
| ADA ID: F476117A992C | Ramp Type: Perp | Initial Pass/Fail: Fail | Overall Compliance: No |
| Severity Score: 13.75 | | | |

**R304.2.2, R304.5.3**

| Compliance | Description | Data | Compliance | Description | Data |
|---|---|---|---|---|---|
| N/A | Ramp Length (in) | 27.0 | No | Ramp Slope (%) | 9.8 |
| Yes | Ramp Width (in) | 48.0 | No | Ramp XSlope (%) | 3.5 |

**Remove & Replace Entire Ramp.**

Total Cost: \$ 1850.00
