Access Compliance Report

Public Rights-of-Way

(Curb Ramps)

Intersection ID: 29422	Main Street: BRADSTREET_COMMONS_WY	Cross Street: SHINY_MEADOW_LN	Location: SW
ADA ID: F47CE5EC5EF1	Ramp Type: Perp	Initial Pass/Fail: Fail	Overall Compliance: No
Severity Score: 46.25			
Codes/Mitigation Info/Possible Solution		Field Measurements/Component Compliance

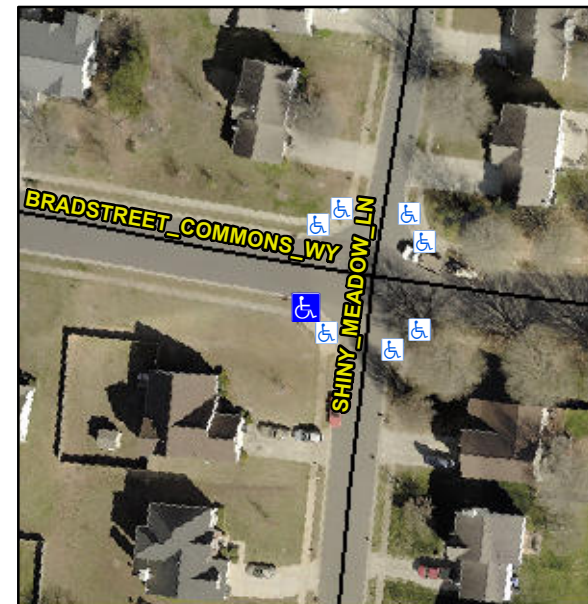
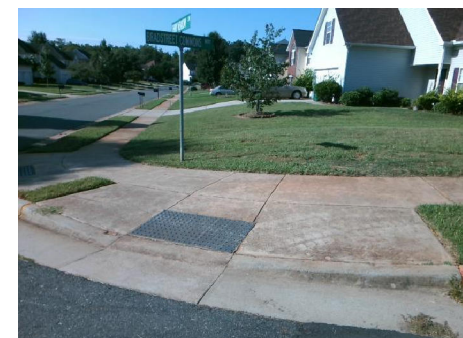
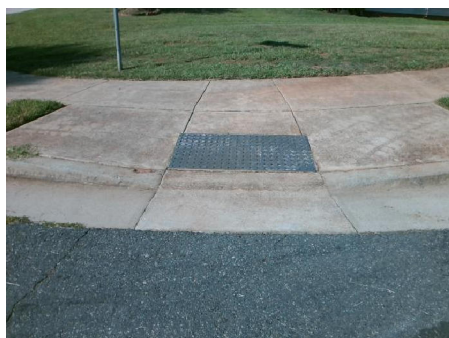
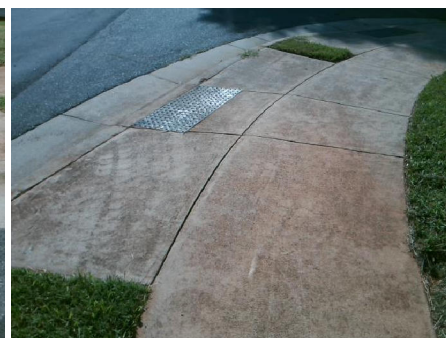
Not Found, R304.5.1, R304.2.2, R304.5.3

Compliance	Description	Data	Compliance	Description	Data
N/A	Ramp Length (in)	46.0	No	Ramp Slope (%)	13.9
No	Ramp Width (in)	42.0	No	Ramp XSlope (%)	6.3
N/A	Flare Type LT	N/A	N/A	Flare Type RT	N/A
N/A	Flare Slope LT (%)	N/A	N/A	Flare Slope RT (%)	N/A
N/A	Flare Traversable LT?	N/A	N/A	Flare Traversable RT?	N/A
N/A	Landing Length (in)	N/A	N/A	DWS Provided?	N/A
N/A	Landing Width (in)	N/A	N/A	DWS Contrast?	N/A
N/A	Landing Slope (%)	N/A	N/A	DWS Length (in)	N/A
N/A	Landing X Slope (%)	N/A	N/A	DWS Full Width?	N/A
N/A	Landing Curb? (Y/N)	N/A	N/A	DWS Offset (in)	N/A
N/A	Shared Landing?	N/A			
N/A	Gutter Ponding?	N/A	N/A	Gutter Slope (%)	N/A
N/A	Gutter Lip Ht (in)	N/A	N/A	Gutter X Slope (%)	N/A
N/A	Painted X Walk1?	No	N/A	Painted X Walk2?	N/A
	X Walk 1 Direction	To N		X Walk 2 Direction	N/A
N/A	X Walk 1 Width (in)	N/A	N/A	X Walk 2 Width (in)	N/A
	X Walk 1 Slope (%)	3.5		X Walk 2 Slope (%)	N/A
	X Walk 1 X Slope (%)	8.2		X Walk 2 X Slope (%)	N/A

N/A	Ramp inside XWalk1?	N/A	N/A	Ramp inside XWalk2?	N/A
	Road Slope (%)	N/A	N/A	Clear Space?	N/A
	Road X Slope (%)	N/A	N/A	Clear Space to XWalk (in)	N/A
N/A	Any Obstructions?	N/A	N/A	Storm Grate/Utility Hazard?	N/A
	Obstruction Type			Storm Grate/Utility Type	
		N/A			N/A
			Yes	Surface Condition? (G/P)	Good

Possible Solutions:

Remove & Replace Entire Ramp.
