# Access Compliance Report

## Public Rights-of-Way

### (Curb Ramps)

Intersection ID: 20018	Main Street: PARK_RD	Cross Street: FAIRVIEW_RD	Location: SW
ADA ID: F47CFA291476	Ramp Type: Perp	Initial Pass/Fail: Fail	Overall Compliance: No
Codes/Mitigation Info/Possible Solution		Field Measurements/Component Compliance	
Severity Score: 37.5

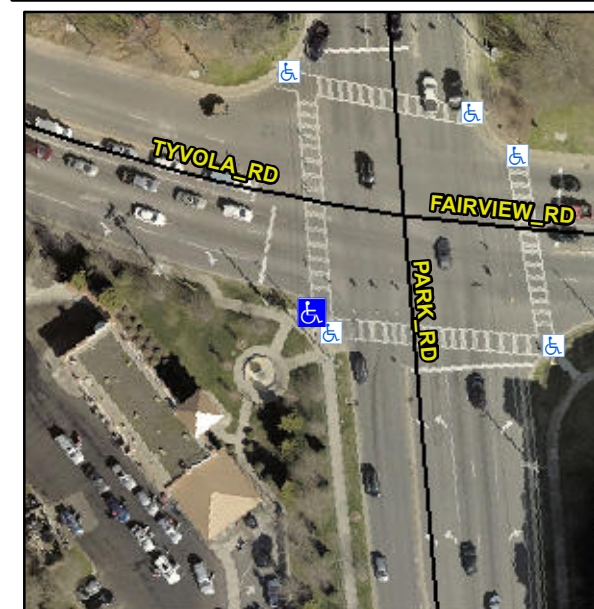
**Not Found, R304.2.2, R304.5.3**

Compliance	Description	Data	Compliance	Description	Data
N/A	Ramp Length (in)	57.0	No	Ramp Slope (%)	8.9
Yes	Ramp Width (in)	48.0	No	Ramp XSlope (%)	8.3
N/A	Flare Type LT	N/A	N/A	Flare Type RT	N/A
N/A	Flare Slope LT (%)	N/A	N/A	Flare Slope RT (%)	N/A
N/A	Flare Traversable LT?	N/A	N/A	Flare Traversable RT?	N/A
N/A	Landing Length (in)	N/A	N/A	DWS Provided?	N/A
N/A	Landing Width (in)	N/A	N/A	DWS Contrast?	N/A
N/A	Landing Slope (%)	N/A	N/A	DWS Length (in)	N/A
N/A	Landing X Slope (%)	N/A	N/A	DWS Full Width?	N/A
N/A	Landing Curb? (Y/N)	N/A	N/A	DWS Offset (in)	N/A
N/A	Shared Landing?	N/A			
N/A	Gutter Ponding?	N/A	N/A	Gutter Slope (%)	N/A
N/A	Gutter Lip Ht (in)	N/A	N/A	Gutter X Slope (%)	N/A
N/A	Painted X Walk1?	Yes	N/A	Painted X Walk2?	N/A
	X Walk 1 Direction	To N		X Walk 2 Direction	N/A
N/A	X Walk 1 Width (in)	110.0	N/A	X Walk 2 Width (in)	N/A
	X Walk 1 Slope (%)	5.7		X Walk 2 Slope (%)	N/A
	X Walk 1 X Slope (%)	7.1		X Walk 2 X Slope (%)	N/A

N/A	Ramp inside XWalk1?	Yes	N/A	Ramp inside XWalk2?	N/A
	Road Slope (%)	N/A	N/A	Clear Space?	N/A
	Road X Slope (%)	N/A	N/A	Clear Space to XWalk (in)	N/A
N/A	Any Obstructions?	N/A	N/A	Storm Grate/Utility Hazard?	N/A
	Obstruction Type			Storm Grate/Utility Type	
		N/A			N/A
		Yes		Surface Condition? (G/P)	Good

**Remove & Replace Entire Ramp.**

Total Cost: \$ 1850.00
