# Access Compliance Report

## Public Rights-of-Way

| Intersection ID: 15300 | Main Street: GREENHAVEN_LN | Cross Street: PIERSON_DR | Location: SE |
| ADA ID: F47E95804ADC | Ramp Type: Directional1 | Initial Pass/Fail: Pass | Overall Compliance: No |

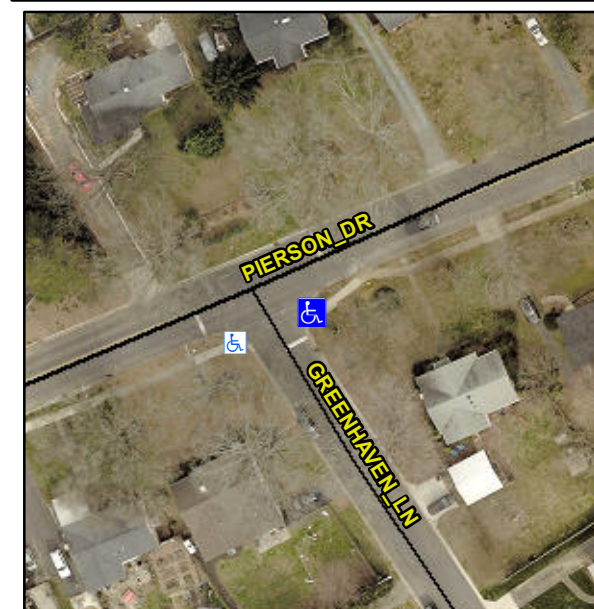
**Not Found, R304.2.2-Perp, R304.3.2-  
Para, R305.2, R304.5.3**

| Compliance | Description | Data | Compliance | Description | Data |
|---|---|---|---|---|---|
| No | Landing Slope (%) | 5.0 | Yes | DWS Length (in) | 24.0 |
| N/A | Landing Curb? (Y/N) | N/A | No | DWS Offset LT (in) | 14.0 |
| Yes | Gutter Lip Ht (in) | 0.0 | No | Gutter X Slope (%) | 2.8 |

**Remove & Replace Entire Ramp.  
Remove & Replace Gutter.**
