Access Compliance Report

Public Rights-of-Way

(Curb Ramps)

Intersection ID: 10028782	Main Street: HUNTINGTOWNE_FARMS_LN	Cross Street: N/A	Location: SW
ADA ID: F47EDF9055CC	Ramp Type: Perp	Initial Pass/Fail: Fail	Overall Compliance: No
Severity Score: 13.75			
Codes/Mitigation Info/Possible Solution		Field Measurements/Component Compliance

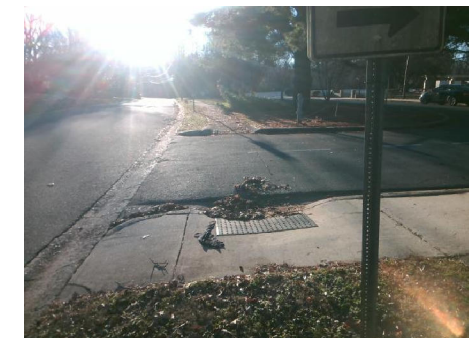
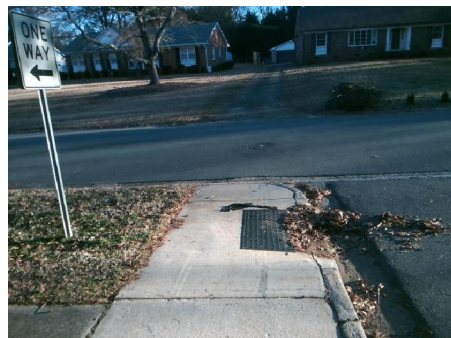
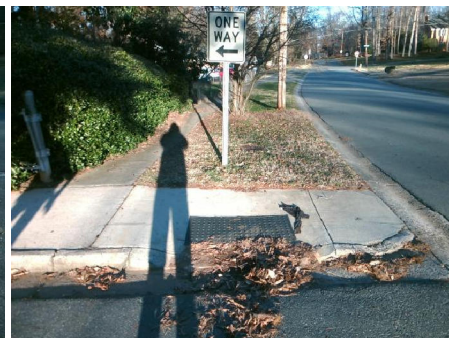
Compliance	Description	Data	Compliance	Description	Data
N/A	Ramp Length (in)	48.0	No	Ramp Slope (%)	11.1
Yes	Ramp Width (in)	48.0	No	Ramp XSlope (%)	5.0
N/A	Flare Type LT	N/A	N/A	Flare Type RT	N/A
N/A	Flare Slope LT (%)	N/A	N/A	Flare Slope RT (%)	N/A
N/A	Flare Traversable LT?	N/A	N/A	Flare Traversable RT?	N/A
N/A	Landing Length (in)	N/A	N/A	DWS Provided?	N/A
N/A	Landing Width (in)	N/A	N/A	DWS Contrast?	N/A
N/A	Landing Slope (%)	N/A	N/A	DWS Length (in)	N/A
N/A	Landing X Slope (%)	N/A	N/A	DWS Full Width?	N/A
N/A	Landing Curb? (Y/N)	N/A	N/A	DWS Offset (in)	N/A
N/A	Shared Landing?	N/A			
N/A	Gutter Ponding?	N/A	N/A	Gutter Slope (%)	N/A
N/A	Gutter Lip Ht (in)	N/A	N/A	Gutter X Slope (%)	N/A
N/A	Painted X Walk1?	No	N/A	Painted X Walk2?	N/A
	X Walk 1 Direction	To SE		X Walk 2 Direction	N/A
N/A	X Walk 1 Width (in)	N/A	N/A	X Walk 2 Width (in)	N/A
	X Walk 1 Slope (%)	3.2		X Walk 2 Slope (%)	N/A
	X Walk 1 X Slope (%)	0.9		X Walk 2 X Slope (%)	N/A

N/A	Ramp inside XWalk1?	N/A	N/A	Ramp inside XWalk2?	N/A
	Road Slope (%)	N/A	N/A	Clear Space?	N/A
	Road X Slope (%)	N/A	N/A	Clear Space to XWalk (in)	N/A
N/A	Any Obstructions?	N/A	N/A	Storm Grate/Utility Hazard?	N/A
	Obstruction Type			Storm Grate/Utility Type	
		N/A			N/A
			Yes	Surface Condition? (G/P)	Good

Possible Solutions:

Remove & Replace Entire Ramp.
