# Access Compliance Report

## Public Rights-of-Way

### (Curb Ramps)

Intersection ID: 32287	Main Street: ALLYSON PARK DR	Cross Street: BAILEYWICK RD	Location: SE
ADA ID: F47F231B8FE7	Ramp Type: PerpDiag	Initial Pass/Fail: Fail	Overall Compliance: No
Codes/Mitigation Info/Possible Solution		Field Measurements/Component Compliance	
Severity Score: 21.25

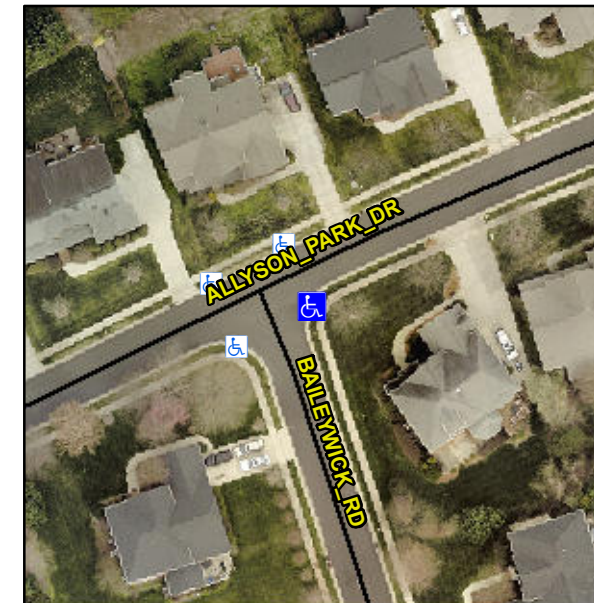
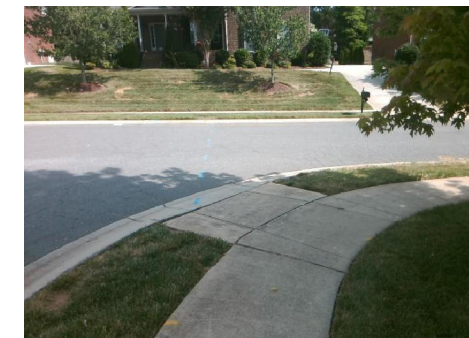
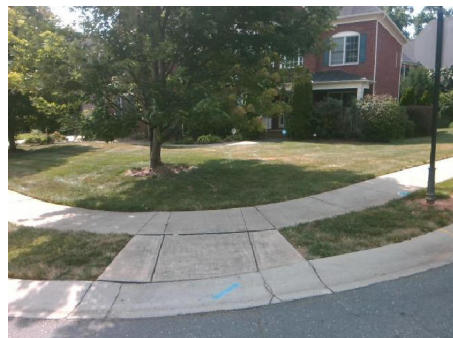
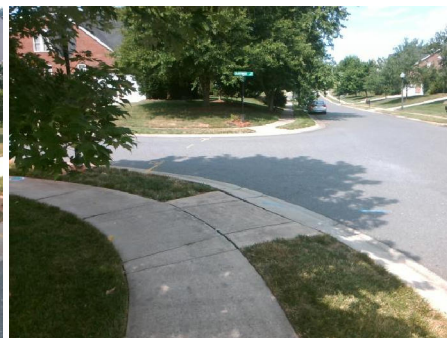
**Not Found, R304.5.1, R304.5.3**

Compliance	Description	Data	Compliance	Description	Data
N/A	Ramp Length (in)	47.5	Yes	Ramp Slope (%)	7.5
No	Ramp Width (in)	47.5	No	Ramp XSlope (%)	5.5
N/A	Flare Type LT	N/A	N/A	Flare Type RT	N/A
N/A	Flare Slope LT (%)	N/A	N/A	Flare Slope RT (%)	N/A
N/A	Flare Traversable LT?	N/A	N/A	Flare Traversable RT?	N/A
N/A	Landing Length (in)	N/A	N/A	DWS Provided?	N/A
N/A	Landing Width (in)	N/A	N/A	DWS Contrast?	N/A
N/A	Landing Slope (%)	N/A	N/A	DWS Length (in)	N/A
N/A	Landing X Slope (%)	N/A	N/A	DWS Full Width?	N/A
N/A	Landing Curb? (Y/N)	N/A	N/A	DWS Offset (in)	N/A
N/A	Shared Landing?	N/A			
N/A	Gutter Ponding?	N/A	N/A	Gutter Slope (%)	N/A
N/A	Gutter Lip Ht (in)	N/A	N/A	Gutter X Slope (%)	N/A
N/A	Painted X Walk1?	No	N/A	Painted X Walk2?	No
	X Walk 1 Direction	To N		X Walk 2 Direction	To W
N/A	X Walk 1 Width (in)	N/A	N/A	X Walk 2 Width (in)	N/A
	X Walk 1 Slope (%)	0.8		X Walk 2 Slope (%)	5.0
	X Walk 1 X Slope (%)	5.0		X Walk 2 X Slope (%)	1.2

N/A	Ramp inside XWalk1?	N/A	N/A	Ramp inside XWalk2?	N/A
	Road Slope (%)	4.4	N/A	Clear Space?	N/A
	Road X Slope (%)	4.1	N/A	Clear Space to XWalk (in)	N/A
N/A	Any Obstructions?	N/A	N/A	Storm Grate/Utility Hazard?	N/A
	Obstruction Type			Storm Grate/Utility Type	
		N/A			N/A
		Yes		Surface Condition? (G/P)	Good

**Remove & Replace Curb Ramp With Two New Directional Ramps or Equivalent.**
