Access Compliance Report

Public Rights-of-Way

(Curb Ramps)

Intersection ID: 54218	Main Street: GOLF_LINKS_DR	Cross Street: SANDY_ROCK_PL	Location: SE
ADA ID: F48EAEAE220C	Ramp Type: Directional1	Initial Pass/Fail: Fail	Overall Compliance: No
		Severity Score: 12.5	
Codes/Mitigation Info/Possible Solution		Field Measurements/Component Compliance

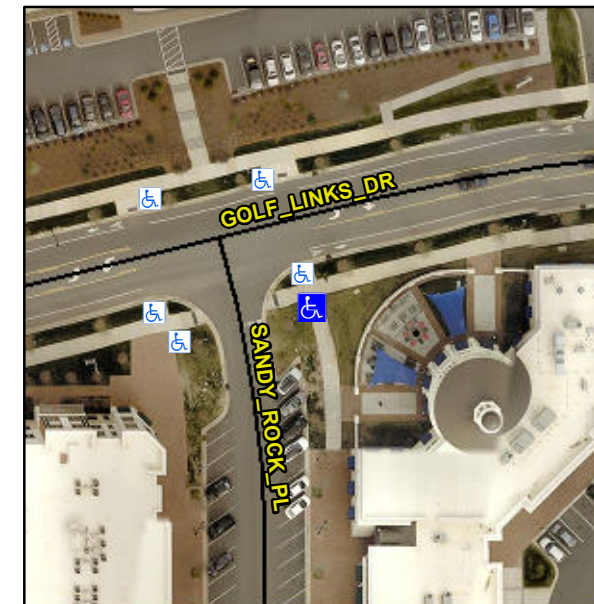
Compliance	Description	Data	Compliance	Description	Data
N/A	Ramp Length (in)	87.0	N/A	Grade Break?	N/A
Yes	Ramp Width (in)	87.0	N/A	Grade Break Slope (%)	0.0
No	Ramp Slope (%)	9.6	N/A	Grade Break XSlope (%)	0.0
Yes	Ramp XSlope (%)	0.7			
N/A	Flare Type LT	N/A	N/A	Flare Type RT	N/A
N/A	Flare Slope LT (%)	N/A	N/A	Flare Slope RT (%)	0.0
N/A	Flare Traversable LT?	N/A	N/A	Flare Traversable RT?	N/A
N/A	Landing Length (in)	0.0	N/A	DWS Provided?	N/A
N/A	Landing Width (in)	0.0	N/A	DWS Contrast?	N/A
N/A	Landing Slope (%)	0.0	N/A	DWS Length (in)	N/A
N/A	Landing X Slope (%)	0.0	N/A	DWS Full Width?	N/A
N/A	Landing Curb? (Y/N)	N/A	N/A	DWS Offset LT (in)	N/A
N/A	Shared Landing?	N/A	N/A	DWS Offset RT (in)	N/A
N/A	Gutter Ponding?	0.0	N/A	Gutter Slope (%)	N/A
N/A	Gutter Lip Ht (in)	0.0	N/A	Gutter X Slope (%)	N/A
N/A	Painted X Walk1?	No		Road Slope (%)	0.6
	X Walk 1 Direction	To W		Road X Slope (%)	0.5
	X Walk 1 Width (in)	N/A		Clear Space?	N/A

X Walk 1 Slope (%)	0.6	N/A	Clear Space to XWalk (in)	N/A
	X Walk 1 X Slope (%)	0.5	N/A	Storm Grate/Utility Hazard?	N/A
N/A	Ramp inside XWalk1?	N/A		Storm Grate/Utility Type	
N/A	Any Obstructions?	N/A			N/A
	Obstruction Type		Yes	Surface Condition? (G/P)	Good
			N/A	Curb Slope (%)	10.9

Possible Solutions:

Remove & Replace Entire Ramp.
