Access Compliance Report

Public Rights-of-Way

(Curb Ramps)

Intersection ID: 9734	Main Street: FREEDOM_DR	Cross Street: S_I-85_HY	Location: W
ADA ID: F49C5752C367	Ramp Type: Perp	Initial Pass/Fail: Fail	Overall Compliance: No
Severity Score: 21.25			
Codes/Mitigation Info/Possible Solution		Field Measurements/Component Compliance

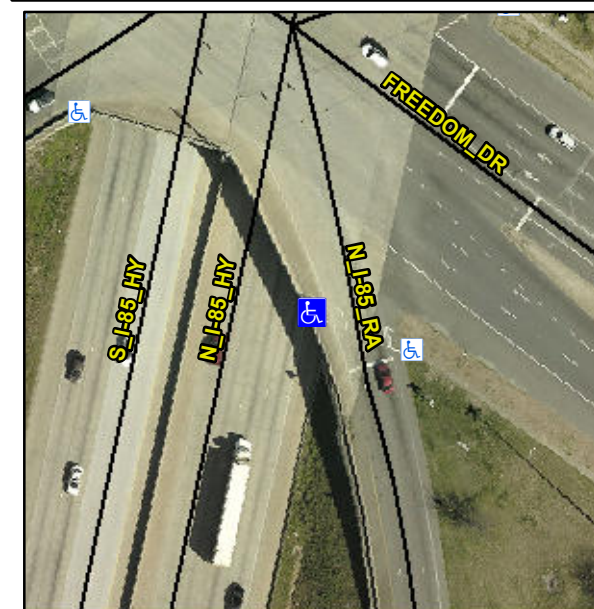
Compliance	Description	Data	Compliance	Description	Data
N/A	Ramp Length (in)	84.0	No	Ramp Slope (%)	10.7
No	Ramp Width (in)	47.0	Yes	Ramp XSlope (%)	0.9
N/A	Flare Type LT	N/A	N/A	Flare Type RT	N/A
N/A	Flare Slope LT (%)	N/A	N/A	Flare Slope RT (%)	N/A
N/A	Flare Traversable LT?	N/A	N/A	Flare Traversable RT?	N/A
N/A	Landing Length (in)	N/A	N/A	DWS Provided?	N/A
N/A	Landing Width (in)	N/A	N/A	DWS Contrast?	N/A
N/A	Landing Slope (%)	N/A	N/A	DWS Length (in)	N/A
N/A	Landing X Slope (%)	N/A	N/A	DWS Full Width?	N/A
N/A	Landing Curb? (Y/N)	N/A	N/A	DWS Offset (in)	N/A
N/A	Shared Landing?	N/A			
N/A	Gutter Ponding?	N/A	N/A	Gutter Slope (%)	N/A
N/A	Gutter Lip Ht (in)	N/A	N/A	Gutter X Slope (%)	N/A
N/A	Painted X Walk1?	Yes	N/A	Painted X Walk2?	N/A
	X Walk 1 Direction	To SE		X Walk 2 Direction	N/A
N/A	X Walk 1 Width (in)	103.0	N/A	X Walk 2 Width (in)	N/A
	X Walk 1 Slope (%)	0.2		X Walk 2 Slope (%)	N/A
	X Walk 1 X Slope (%)	1.3		X Walk 2 X Slope (%)	N/A

N/A	Ramp inside XWalk1?	Yes	N/A	Ramp inside XWalk2?	N/A
	Road Slope (%)	N/A	N/A	Clear Space?	N/A
	Road X Slope (%)	N/A	N/A	Clear Space to XWalk (in)	N/A
N/A	Any Obstructions?	N/A	N/A	Storm Grate/Utility Hazard?	N/A
	Obstruction Type			Storm Grate/Utility Type	
		N/A			N/A
		Yes		Surface Condition? (G/P)	Good

Possible Solutions:

Remove & Replace Entire Ramp.

R304.5.1, R304.2.2
