Access Compliance Report

Public Rights-of-Way

(Curb Ramps)

Intersection ID: 53972	Main Street: SHOPTON_RD_WEST	Cross Street: CADEN_RD	Location: NE
ADA ID: F49DF34C5567	Ramp Type: Perp	Initial Pass/Fail: Fail	Overall Compliance: No
Severity Score: 13.75			
Codes/Mitigation Info/Possible Solution		Field Measurements/Component Compliance

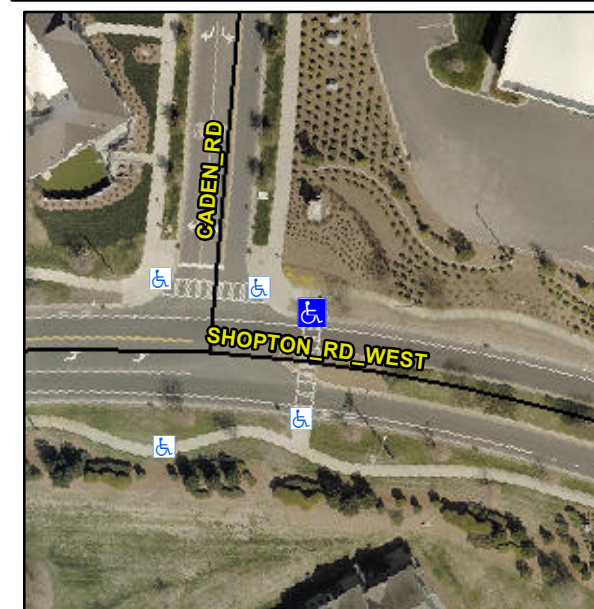
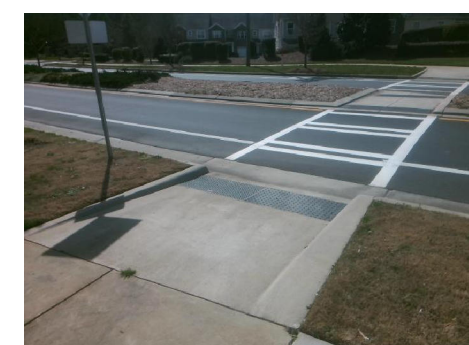
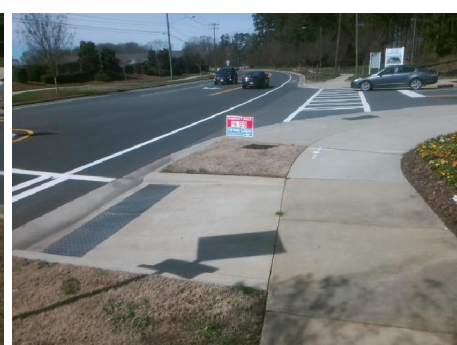
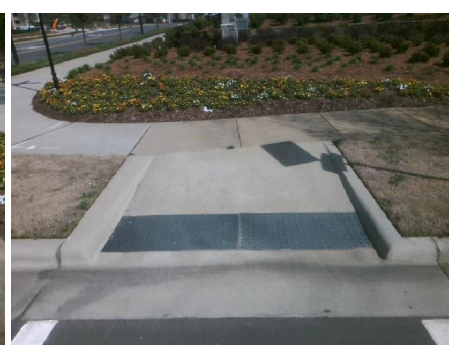
R304.2.2, R304.5.3

Compliance	Description	Data	Compliance	Description	Data
N/A	Ramp Length (in)	97.5	No	Ramp Slope (%)	11.1
Yes	Ramp Width (in)	97.0	No	Ramp XSlope (%)	2.5
N/A	Flare Type LT	N/A	N/A	Flare Type RT	N/A
N/A	Flare Slope LT (%)	N/A	N/A	Flare Slope RT (%)	N/A
N/A	Flare Traversable LT?	N/A	N/A	Flare Traversable RT?	N/A
N/A	Landing Length (in)	N/A	N/A	DWS Provided?	N/A
N/A	Landing Width (in)	N/A	N/A	DWS Contrast?	N/A
N/A	Landing Slope (%)	N/A	N/A	DWS Length (in)	N/A
N/A	Landing X Slope (%)	N/A	N/A	DWS Full Width?	N/A
N/A	Landing Curb? (Y/N)	N/A	N/A	DWS Offset (in)	N/A
N/A	Shared Landing?	N/A			
N/A	Gutter Ponding?	N/A	N/A	Gutter Slope (%)	N/A
N/A	Gutter Lip Ht (in)	N/A	N/A	Gutter X Slope (%)	N/A
N/A	Painted X Walk1?	Yes	N/A	Painted X Walk2?	N/A
	X Walk 1 Direction	To S		X Walk 2 Direction	N/A
N/A	X Walk 1 Width (in)	95.0	N/A	X Walk 2 Width (in)	N/A
	X Walk 1 Slope (%)	2.0		X Walk 2 Slope (%)	N/A
	X Walk 1 X Slope (%)	1.7		X Walk 2 X Slope (%)	N/A

N/A	Ramp inside XWalk1?	Yes	N/A	Ramp inside XWalk2?	N/A
	Road Slope (%)	N/A	N/A	Clear Space?	N/A
	Road X Slope (%)	N/A	N/A	Clear Space to XWalk (in)	N/A
N/A	Any Obstructions?	N/A	N/A	Storm Grate/Utility Hazard?	N/A
	Obstruction Type			Storm Grate/Utility Type	
		N/A			N/A
			Yes	Surface Condition? (G/P)	Good

Remove & Replace Entire Ramp.

Total Cost: \$ 1850.00
