# Access Compliance Report

## Public Rights-of-Way

### (Curb Ramps)

Intersection ID: 8735	Main Street: GLENWOOD_DR	Cross Street: ROWAN_ST	Location: S
ADA ID: F49EAB289843	Ramp Type: Para	Initial Pass/Fail: Fail	Overall Compliance: No
Codes/Mitigation Info/Possible Solution		Field Measurements/Component Compliance	
Severity Score: 12.5

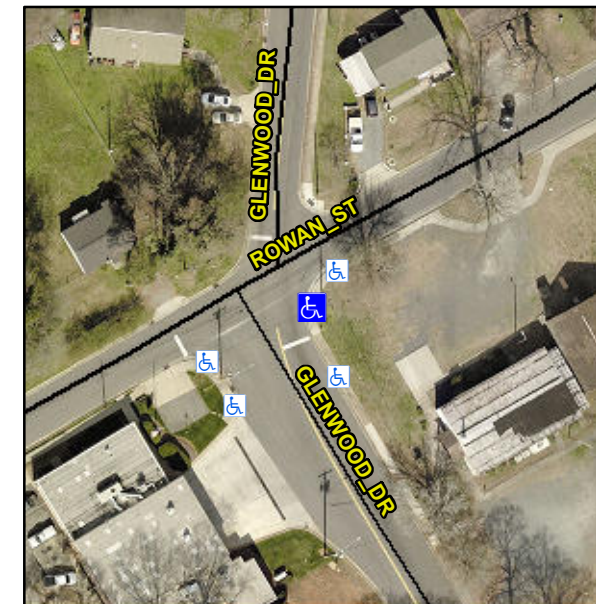
**LT RP < 5%**

**R304.3.2**

Compliance	Description	Data	Compliance	Description	Data
N/A	Ramp Length LT (in)	70.0	N/A	Ramp Length RT (in)	70.0
Yes	Ramp Width LT (in)	48.2	Yes	Ramp Width RT (in)	48.0
Yes	Ramp Slope LT (%)	2.9	No	Ramp Slope RT (%)	10.8
Yes	Ramp XSlope LT (%)	1.8	Yes	Ramp XSlope RT (%)	1.6
N/A	Landing Length (in)	N/A	N/A	DWS Provided?	N/A
N/A	Landing Width (in)	N/A	N/A	DWS Contrast?	N/A
N/A	Landing Slope (%)	N/A	N/A	DWS Length (in)	N/A
N/A	Landing X Slope (%)	N/A	N/A	DWS Full Width?	N/A
N/A	Landing Curb? (Y/N)	N/A	N/A	DWS Offset (in)	N/A
N/A	Shared Landing?	N/A			
N/A	Gutter Ponding?	N/A	N/A	Gutter Slope (%)	N/A
N/A	Gutter Lip Ht (in)	N/A	N/A	Gutter X Slope (%)	N/A
N/A	Painted X Walk1?	No	N/A	Painted X Walk2?	N/A
	X Walk 1 Direction	To N		X Walk 2 Direction	N/A
N/A	X Walk 1 Width (in)	N/A	N/A	X Walk 2 Width (in)	N/A
	X Walk 1 Slope (%)	3.1		X Walk 2 Slope (%)	N/A
	X Walk 1 X Slope (%)	4.3		X Walk 2 X Slope (%)	N/A
N/A	Ramp inside XWalk1?	N/A	N/A	Ramp inside XWalk2?	N/A

**Remove & Replace Entire Ramp.**
