# Access Compliance Report

## Public Rights-of-Way

### (Curb Ramps)

| Intersection ID: 22792 | Main Street: HUNTERS_LANDING_DR | Cross Street: MOSS_RD | Location: SW |

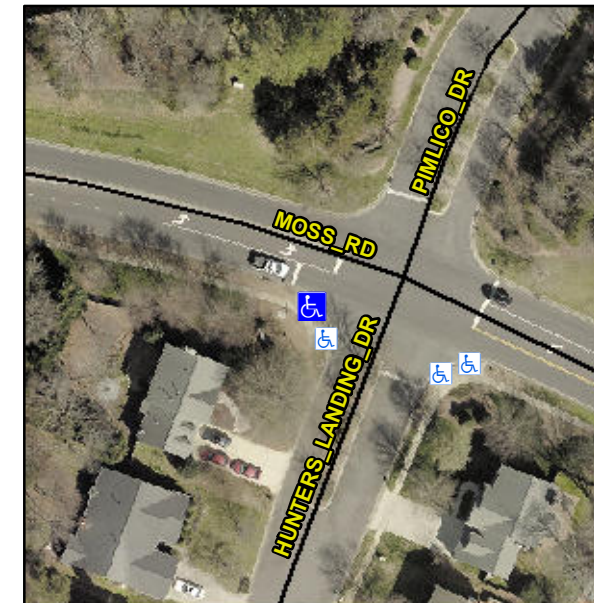
| ADA ID: F4AF6C94D734 | Ramp Type: Perp | Initial Pass/Fail: Fail | Overall Compliance: No |
| | | Severity Score: 12.5 | |

**R304.2.2**

| Compliance | Description | Data | Compliance | Description | Data |
|---|---|---|---|---|---|
| N/A | Ramp Length (in) | 120.0 | No | Ramp Slope (%) | 10.1 |
| Yes | Ramp Width (in) | 48.0 | Yes | Ramp XSlope (%) | 0.2 |

**Remove & Replace Entire Ramp.**

**\$ 1850.00**
