# Access Compliance Report

## Public Rights-of-Way

### (Curb Ramps)

| Intersection ID: N/A | Main Street: TRYON_ST | Cross Street: PUMPERNICKEL_RD | Location: SW |

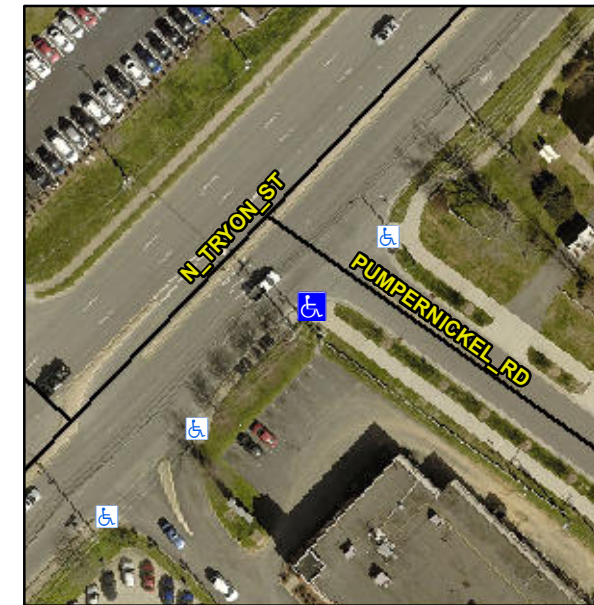
| ADA ID: F4B3AC81F062 | Ramp Type: PerpDiag | Initial Pass/Fail: Fail | Overall Compliance: No |
| | | Severity Score: 12.5 | |

**R304.2.2**

| Compliance | Description | Data | Compliance | Description | Data |
|---|---|---|---|---|---|
| N/A | Ramp Length (in) | 55.0 | No | Ramp Slope (%) | 9.1 |

**Remove & Replace Curb Ramp With Two New Directional Ramps or Equivalent.**

Total Cost: \$ 3200.00
