Access Compliance Report

Public Rights-of-Way

(Curb Ramps)

Intersection ID: 31278	Main Street: W_MALLARD_CREEK_CHURCH_RD	Cross Street: MALLARD_GLEN_DR	Location: E
ADA ID: F4B74D1099F6	Ramp Type: PerpDiag	Initial Pass/Fail: Fail	Overall Compliance: No
		Severity Score: 26.25

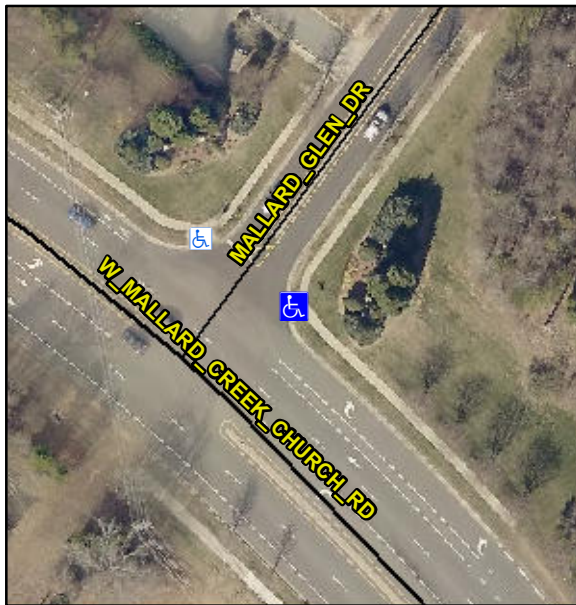
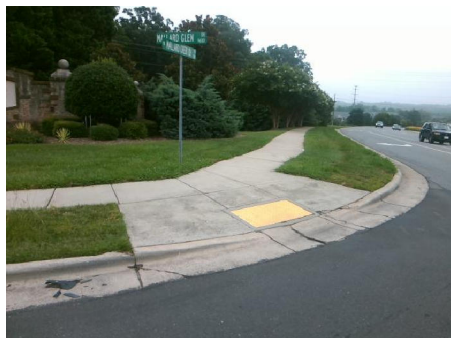
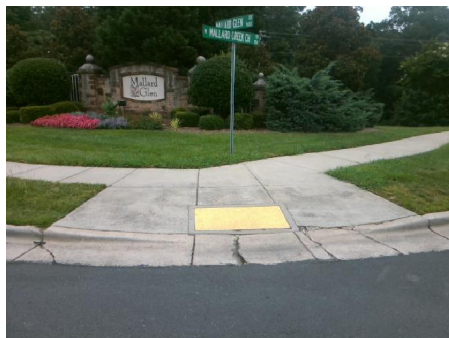
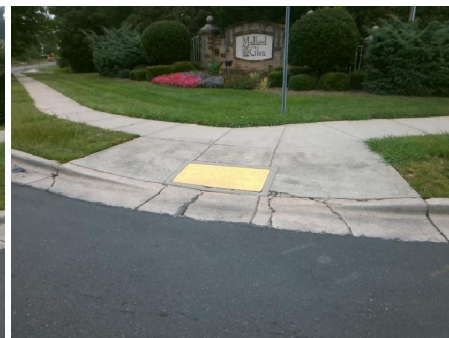
Compliance	Description	Data	Compliance	Description	Data
N/A	Ramp Length (in)	60.0	No	Ramp Slope (%)	14.0
Yes	Ramp Width (in)	48.0	No	Ramp XSlope (%)	3.0
N/A	Flare Type LT	N/A	N/A	Flare Type RT	N/A
N/A	Flare Slope LT (%)	N/A	N/A	Flare Slope RT (%)	N/A
N/A	Flare Traversable LT?	N/A	N/A	Flare Traversable RT?	N/A
N/A	Landing Length (in)	N/A	N/A	DWS Provided?	N/A
N/A	Landing Width (in)	N/A	N/A	DWS Contrast?	N/A
N/A	Landing Slope (%)	N/A	N/A	DWS Length (in)	N/A
N/A	Landing X Slope (%)	N/A	N/A	DWS Full Width?	N/A
N/A	Landing Curb? (Y/N)	N/A	N/A	DWS Offset (in)	N/A
N/A	Shared Landing?	N/A			
N/A	Gutter Ponding?	N/A	N/A	Gutter Slope (%)	N/A
N/A	Gutter Lip Ht (in)	N/A	N/A	Gutter X Slope (%)	N/A
N/A	Painted X Walk1?	No	N/A	Painted X Walk2?	No
	X Walk 1 Direction	To NW		X Walk 2 Direction	To SW
N/A	X Walk 1 Width (in)	N/A	N/A	X Walk 2 Width (in)	N/A
	X Walk 1 Slope (%)	1.4		X Walk 2 Slope (%)	3.0
	X Walk 1 X Slope (%)	3.4		X Walk 2 X Slope (%)	3.0

N/A	Ramp inside XWalk1?	N/A	N/A	Ramp inside XWalk2?	N/A
	Road Slope (%)	1.1	N/A	Clear Space?	N/A
	Road X Slope (%)	5.4	N/A	Clear Space to XWalk (in)	N/A
N/A	Any Obstructions?	N/A	N/A	Storm Grate/Utility Hazard?	N/A
	Obstruction Type			Storm Grate/Utility Type	
		N/A			N/A
			Yes	Surface Condition? (G/P)	Good

Remove & Replace Curb Ramp With Two New Directional Ramps or Equivalent.
