Access Compliance Report

Public Rights-of-Way

(Curb Ramps)

Intersection ID: 10031994	Main Street: MONROE_RD	Cross Street: N/A	Location: SE
ADA ID: F4BF8B636AD5	Ramp Type: PerpDiag	Initial Pass/Fail: Fail	Overall Compliance: No
Codes/Mitigation Info/Possible Solution		Field Measurements/Component Compliance	
Severity Score: 22.5

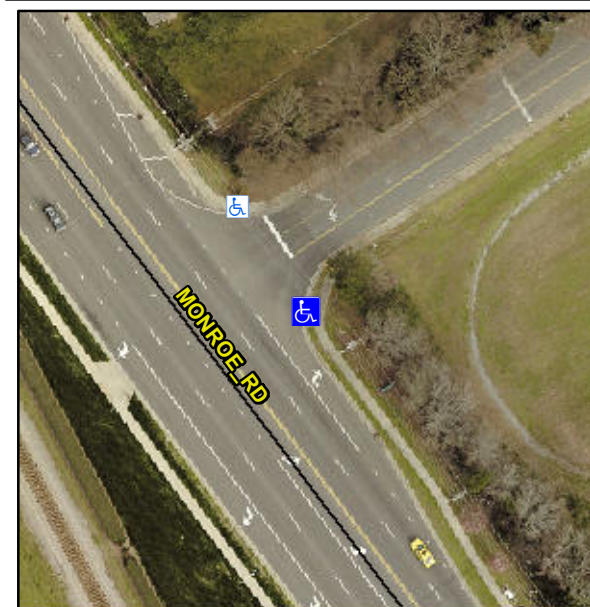
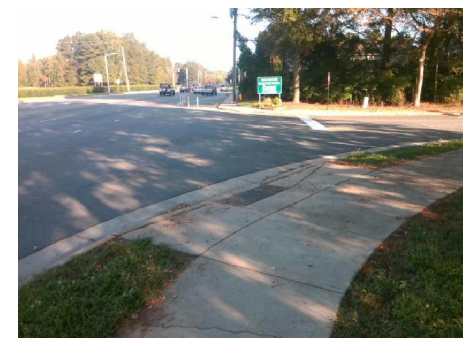
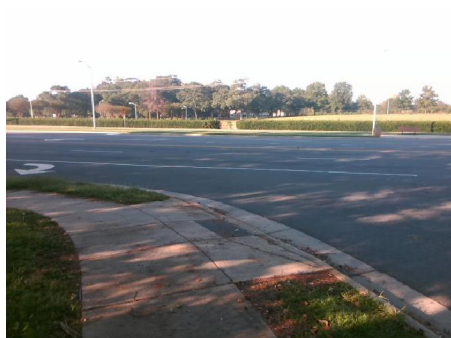
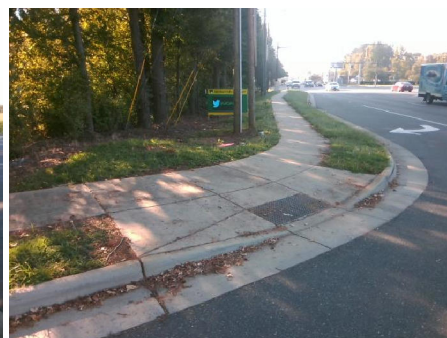
Compliance	Description	Data	Compliance	Description	Data
N/A	Ramp Length (in)	48.0	No	Ramp Slope (%)	8.4
No	Ramp Width (in)	47.5	No	Ramp XSlope (%)	3.3
N/A	Flare Type LT	N/A	N/A	Flare Type RT	N/A
N/A	Flare Slope LT (%)	N/A	N/A	Flare Slope RT (%)	N/A
N/A	Flare Traversable LT?	N/A	N/A	Flare Traversable RT?	N/A
N/A	Landing Length (in)	N/A	N/A	DWS Provided?	N/A
N/A	Landing Width (in)	N/A	N/A	DWS Contrast?	N/A
N/A	Landing Slope (%)	N/A	N/A	DWS Length (in)	N/A
N/A	Landing X Slope (%)	N/A	N/A	DWS Full Width?	N/A
N/A	Landing Curb? (Y/N)	N/A	N/A	DWS Offset (in)	N/A
N/A	Shared Landing?	N/A			
N/A	Gutter Ponding?	N/A	N/A	Gutter Slope (%)	N/A
N/A	Gutter Lip Ht (in)	N/A	N/A	Gutter X Slope (%)	N/A
N/A	Painted X Walk1?	No	N/A	Painted X Walk2?	No
	X Walk 1 Direction	To SW		X Walk 2 Direction	To NW
N/A	X Walk 1 Width (in)	N/A	N/A	X Walk 2 Width (in)	N/A
	X Walk 1 Slope (%)	1.4		X Walk 2 Slope (%)	1.1
	X Walk 1 X Slope (%)	0.2		X Walk 2 X Slope (%)	2.2

N/A	Ramp inside XWalk1?	N/A	N/A	Ramp inside XWalk2?	N/A
	Road Slope (%)	1.7	N/A	Clear Space?	N/A
	Road X Slope (%)	1.1	N/A	Clear Space to XWalk (in)	N/A
N/A	Any Obstructions?	N/A	N/A	Storm Grate/Utility Hazard?	N/A
	Obstruction Type			Storm Grate/Utility Type	
		N/A			N/A
			Yes	Surface Condition? (G/P)	Good

Possible Solutions:

Remove & Replace Curb Ramp With Two New Directional Ramps or Equivalent.

R304.5.1, R304.2.2, R304.5.3
