# Access Compliance Report

## Public Rights-of-Way

### (Curb Ramps)

| Intersection ID: 50609 | Main Street: DOWNY_BIRCH_RD | Cross Street: PADDLE_OAK_RD | Location: NW |

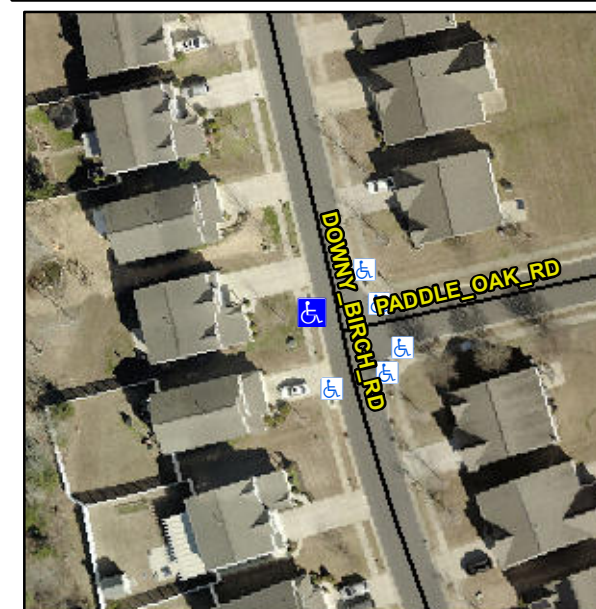
| ADA ID: F4C5642A153E | Ramp Type: Perp | Initial Pass/Fail: Fail | Overall Compliance: No |

**Not Found, R304.2.2**

| Compliance | Description | Data | Compliance | Description | Data |
|---|---|---|---|---|---|
| N/A | Ramp Length (in) | 47.0 | No | Ramp Slope (%) | 9.0 |
| Yes | Ramp Width (in) | 48.0 | Yes | Ramp XSlope (%) | 1.4 |

**Remove & Replace Entire Ramp.**

Total Cost: \$ 1850.00
