Access Compliance Report

Public Rights-of-Way

(Curb Ramps)

Intersection ID: 20800	Main Street: HILLSTONE_CT	Cross Street: SANDY_PORTER_RD	Location: SE
ADA ID: F4D45BDEC790	Ramp Type: Directional1	Initial Pass/Fail: Fail	Overall Compliance: No
Severity Score: 1.25			
Codes/Mitigation Info/Possible Solution		Field Measurements/Component Compliance

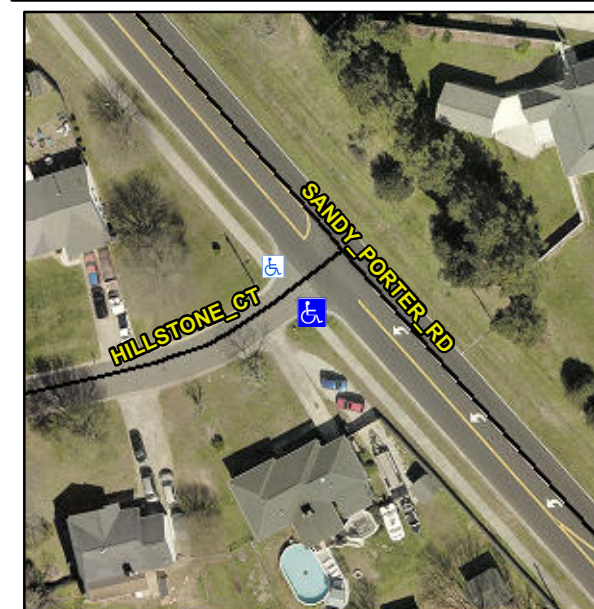
Compliance	Description	Data	Compliance	Description	Data
N/A	Ramp Length (in)	54.0	N/A	Grade Break?	N/A
Yes	Ramp Width (in)	70.0	N/A	Grade Break Slope (%)	0.0
Yes	Ramp Slope (%)	6.2	N/A	Grade Break XSlope (%)	0.0
No	Ramp XSlope (%)	2.4			
N/A	Flare Type LT	N/A	N/A	Flare Type RT	N/A
N/A	Flare Slope LT (%)	N/A	N/A	Flare Slope RT (%)	0.0
N/A	Flare Traversable LT?	N/A	N/A	Flare Traversable RT?	N/A
N/A	Landing Length (in)	0.0	N/A	DWS Provided?	N/A
N/A	Landing Width (in)	0.0	N/A	DWS Contrast?	N/A
N/A	Landing Slope (%)	0.0	N/A	DWS Length (in)	N/A
N/A	Landing X Slope (%)	0.0	N/A	DWS Full Width?	N/A
N/A	Landing Curb? (Y/N)	N/A	N/A	DWS Offset LT (in)	N/A
N/A	Shared Landing?	N/A	N/A	DWS Offset RT (in)	N/A
N/A	Gutter Ponding?	0.0	N/A	Gutter Slope (%)	N/A
N/A	Gutter Lip Ht (in)	0.0	N/A	Gutter X Slope (%)	N/A
N/A	Painted X Walk1?	No		Road Slope (%)	2.3
	X Walk 1 Direction	To NW		Road X Slope (%)	1.7
	X Walk 1 Width (in)	N/A		Clear Space?	N/A

X Walk 1 Slope (%)	2.3	N/A	Clear Space to XWalk (in)	N/A
	X Walk 1 X Slope (%)	1.7	N/A	Storm Grate/Utility Hazard?	N/A
N/A	Ramp inside XWalk1?	N/A		Storm Grate/Utility Type	
N/A	Any Obstructions?	N/A			N/A
	Obstruction Type		Yes	Surface Condition? (G/P)	Good
			N/A	Curb Slope (%)	10.2

Possible Solutions:

Remove & Replace Entire Ramp.

PROW/ADA:

R304.5.3
