Access Compliance Report

Public Rights-of-Way

(Curb Ramps)

Intersection ID: 53349	Main Street: SAPPHIRE_HILL_LN	Cross Street: N/A	Location: SW
ADA ID: F4D9386EBFE1	Ramp Type: Perp	Initial Pass/Fail: Pass	Overall Compliance: No
Codes/Mitigation Info/Possible Solution		Field Measurements/Component Compliance	
Severity Score: 5

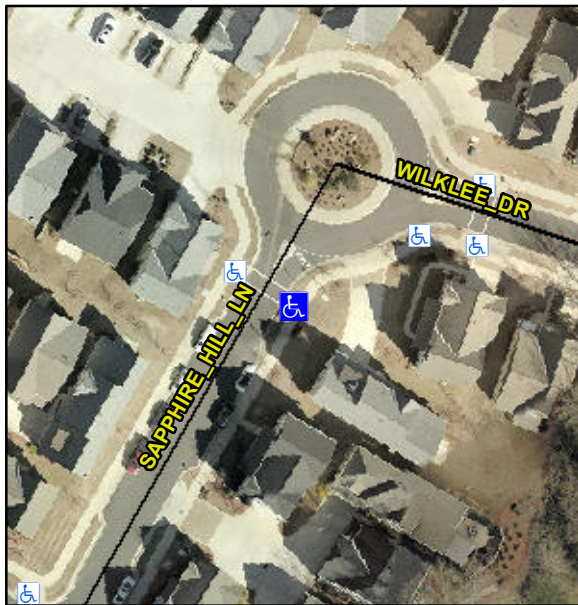
Compliance	Description	Data	Compliance	Description	Data
N/A	Ramp Length (in)	59.5	Yes	Ramp Slope (%)	7.9
Yes	Ramp Width (in)	48.0	Yes	Ramp XSlope (%)	0.1
N/A	Flare Type LT	Sloped	N/A	Flare Type RT	N/A
N/A	Flare Slope LT (%)	10.4	No	Flare Slope RT (%)	12.5
N/A	Flare Traversable LT?	Yes	N/A	Flare Traversable RT?	Yes
Yes	Landing Length (in)	71.5	Yes	DWS Provided?	Yes
Yes	Landing Width (in)	48.0	Yes	DWS Contrast?	Yes
No	Landing Slope (%)	2.2	Yes	DWS Length (in)	24.0
No	Landing X Slope (%)	3.1	Yes	DWS Full Width?	Yes
N/A	Landing Curb? (Y/N)	No	Yes	DWS Offset (in)	2.0
N/A	Shared Landing?	No			
No	Gutter Ponding?	Yes	Yes	Gutter Slope (%)	1.8
Yes	Gutter Lip Ht (in)	0.0	Yes	Gutter X Slope (%)	1.8
N/A	Painted X Walk1?	Yes	N/A	Painted X Walk2?	N/A
	X Walk 1 Direction	To NW		X Walk 2 Direction	N/A
N/A	X Walk 1 Width (in)	87.5	N/A	X Walk 2 Width (in)	N/A
	X Walk 1 Slope (%)	2.9		X Walk 2 Slope (%)	N/A
	X Walk 1 X Slope (%)	1.8		X Walk 2 X Slope (%)	N/A

Yes	Ramp inside XWalk1?	Yes	N/A	Ramp inside XWalk2?	N/A
	Road Slope (%)	N/A	N/A	Clear Space?	Yes
	Road X Slope (%)	N/A	N/A	Clear Space to XWalk (in)	N/A
Yes	Any Obstructions?	No	Yes	Storm Grate/Utility Hazard?	No
	Obstruction Type			Storm Grate/Utility Type	
		N/A			N/A
			Yes	Surface Condition? (G/P)	Good

Possible Solutions:

**Remove & Replace Entire Ramp.
Gutter Ponding Observed.**
