Access Compliance Report

Public Rights-of-Way

(Curb Ramps)

Intersection ID: 11521	Main Street: W_11TH_ST	Cross Street: N_CHURCH_ST	Location:	N
ADA ID: F4E2D18AD6D5	Ramp Type: PerpDiag	Initial Pass/Fail: Fail	Overall Compliance: No	Severity Score: 10

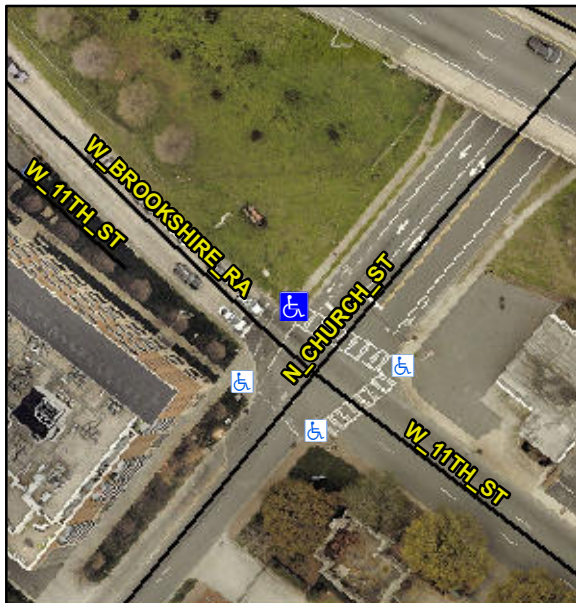
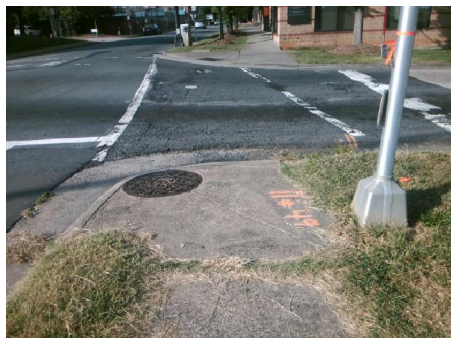
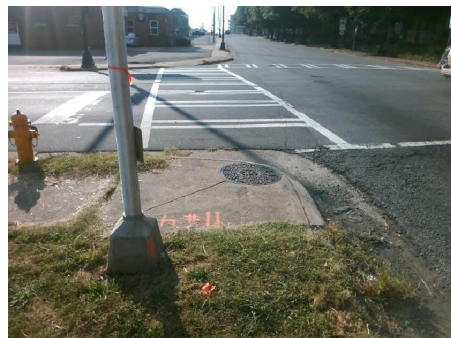
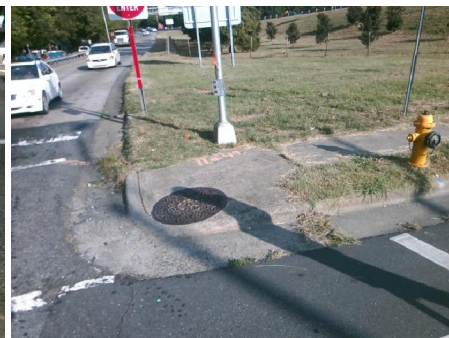
Not Found, R304.5.1, R304.5.3

Compliance	Description	Data	Compliance	Description	Data
N/A	Ramp Length (in)	33.0	Yes	Ramp Slope (%)	6.6
No	Ramp Width (in)	36.0	No	Ramp XSlope (%)	2.3
N/A	Flare Type LT	N/A	N/A	Flare Type RT	N/A
N/A	Flare Slope LT (%)	N/A	N/A	Flare Slope RT (%)	N/A
N/A	Flare Traversable LT?	N/A	N/A	Flare Traversable RT?	N/A
N/A	Landing Length (in)	N/A	N/A	DWS Provided?	N/A
N/A	Landing Width (in)	N/A	N/A	DWS Contrast?	N/A
N/A	Landing Slope (%)	N/A	N/A	DWS Length (in)	N/A
N/A	Landing X Slope (%)	N/A	N/A	DWS Full Width?	N/A
N/A	Landing Curb? (Y/N)	N/A	N/A	DWS Offset (in)	N/A
N/A	Shared Landing?	N/A			
N/A	Gutter Ponding?	N/A	N/A	Gutter Slope (%)	N/A
N/A	Gutter Lip Ht (in)	N/A	N/A	Gutter X Slope (%)	N/A
N/A	Painted X Walk1?	Yes	N/A	Painted X Walk2?	Yes
	X Walk 1 Direction	To SW		X Walk 2 Direction	To SE
N/A	X Walk 1 Width (in)	134.0	N/A	X Walk 2 Width (in)	120.0
	X Walk 1 Slope (%)	3.7		X Walk 2 Slope (%)	4.0
	X Walk 1 X Slope (%)	4.3		X Walk 2 X Slope (%)	4.1

N/A	Ramp inside XWalk1?	Yes	N/A	Ramp inside XWalk2?	Yes
	Road Slope (%)	0.2	N/A	Clear Space?	N/A
	Road X Slope (%)	10.3	N/A	Clear Space to XWalk (in)	N/A
N/A	Any Obstructions?	N/A	N/A	Storm Grate/Utility Hazard?	N/A
	Obstruction Type			Storm Grate/Utility Type	
		N/A			N/A
		Yes		Surface Condition? (G/P)	Good

Remove & Replace Curb Ramp With Two New Directional Ramps or Equivalent.
