# Access Compliance Report

## Public Rights-of-Way

### (Curb Ramps)

| Intersection ID: 27531 | Main Street: BALLANTYNE COMMONS PY | Cross Street: PLANTATION PARK BV | Location: NW |

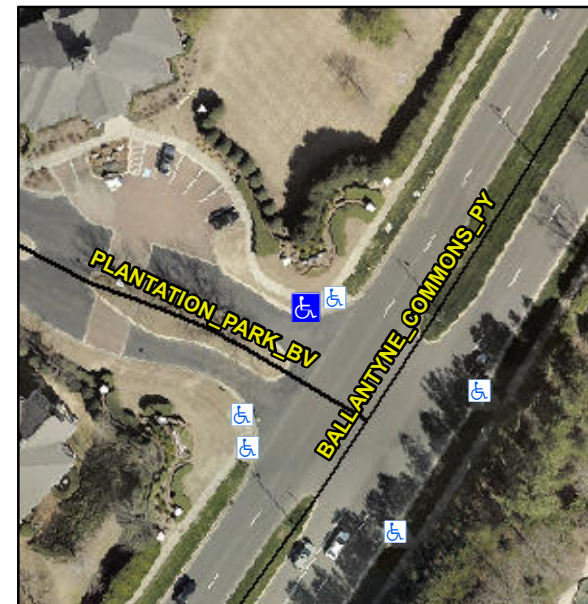
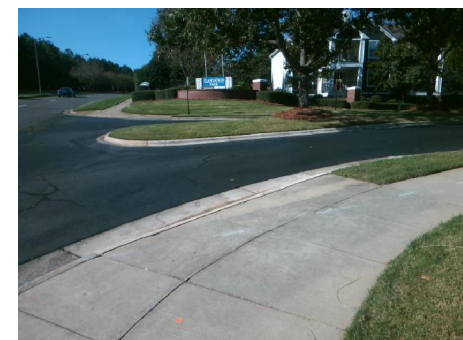
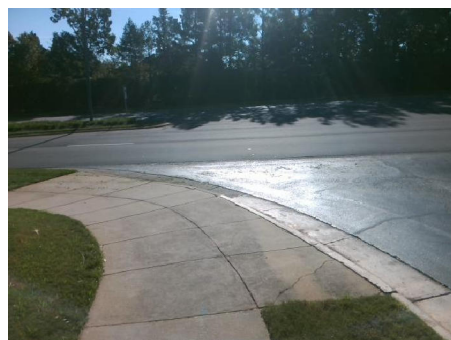
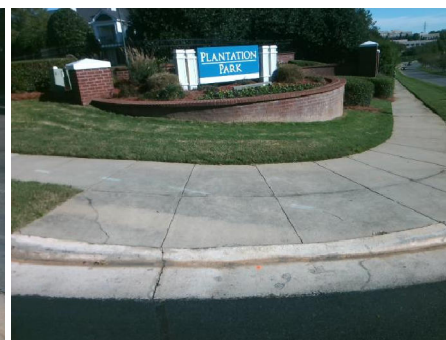
| ADA ID: F4F17D072AD9 | Ramp Type: Perp | Initial Pass/Fail: Fail | Overall Compliance: No |

**Not Found, R304.5.3**

| Compliance | Description | Data | Compliance | Description | Data |
|---|---|---|---|---|---|
| Yes | Ramp Width (in) | 50.0 | No | Ramp XSlope (%) | 7.6 |

**Remove & Replace Entire Ramp.**

Total Cost: \$ 1850.00
