Access Compliance Report

Public Rights-of-Way

(Curb Ramps)

Intersection ID: 14535	Main Street: E_KINGSTON_AV	Cross Street: LENNOX_AV	Location: W
ADA ID: F504BA41A972	Ramp Type: Perp	Initial Pass/Fail: Fail	Overall Compliance: No
Severity Score: 22.5			
Codes/Mitigation Info/Possible Solution		Field Measurements/Component Compliance

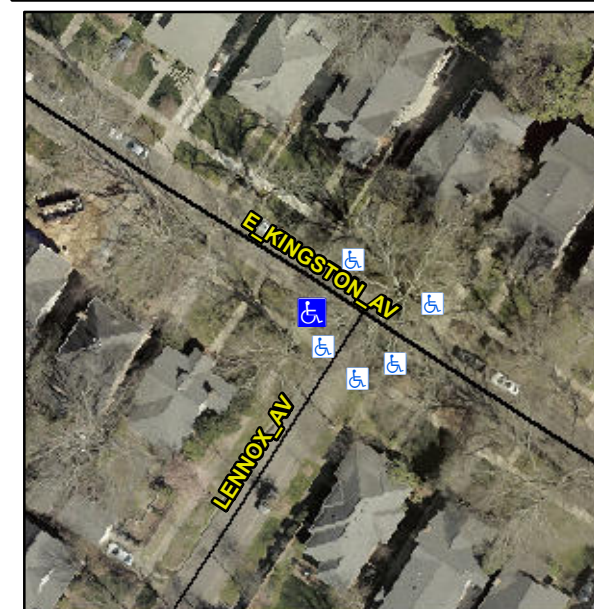
Not Found, R304.5.1, R304.2.2, R304.5.3

Compliance	Description	Data	Compliance	Description	Data
N/A	Ramp Length (in)	86.0	No	Ramp Slope (%)	8.9
No	Ramp Width (in)	44.0	No	Ramp XSlope (%)	4.6
N/A	Flare Type LT	N/A	N/A	Flare Type RT	N/A
N/A	Flare Slope LT (%)	N/A	N/A	Flare Slope RT (%)	N/A
N/A	Flare Traversable LT?	N/A	N/A	Flare Traversable RT?	N/A
N/A	Landing Length (in)	N/A	N/A	DWS Provided?	N/A
N/A	Landing Width (in)	N/A	N/A	DWS Contrast?	N/A
N/A	Landing Slope (%)	N/A	N/A	DWS Length (in)	N/A
N/A	Landing X Slope (%)	N/A	N/A	DWS Full Width?	N/A
N/A	Landing Curb? (Y/N)	N/A	N/A	DWS Offset (in)	N/A
N/A	Shared Landing?	N/A			
N/A	Gutter Ponding?	N/A	N/A	Gutter Slope (%)	N/A
N/A	Gutter Lip Ht (in)	N/A	N/A	Gutter X Slope (%)	N/A
N/A	Painted X Walk1?	No	N/A	Painted X Walk2?	N/A
	X Walk 1 Direction	To NE		X Walk 2 Direction	N/A
N/A	X Walk 1 Width (in)	N/A	N/A	X Walk 2 Width (in)	N/A
	X Walk 1 Slope (%)	5.0		X Walk 2 Slope (%)	N/A
	X Walk 1 X Slope (%)	2.8		X Walk 2 X Slope (%)	N/A

N/A	Ramp inside XWalk1?	N/A	N/A	Ramp inside XWalk2?	N/A
	Road Slope (%)	N/A	N/A	Clear Space?	N/A
	Road X Slope (%)	N/A	N/A	Clear Space to XWalk (in)	N/A
N/A	Any Obstructions?	N/A	N/A	Storm Grate/Utility Hazard?	N/A
	Obstruction Type			Storm Grate/Utility Type	
		N/A			N/A
			Yes	Surface Condition? (G/P)	Good

Possible Solutions:

Remove & Replace Entire Ramp.
