Access Compliance Report

Public Rights-of-Way

(Curb Ramps)

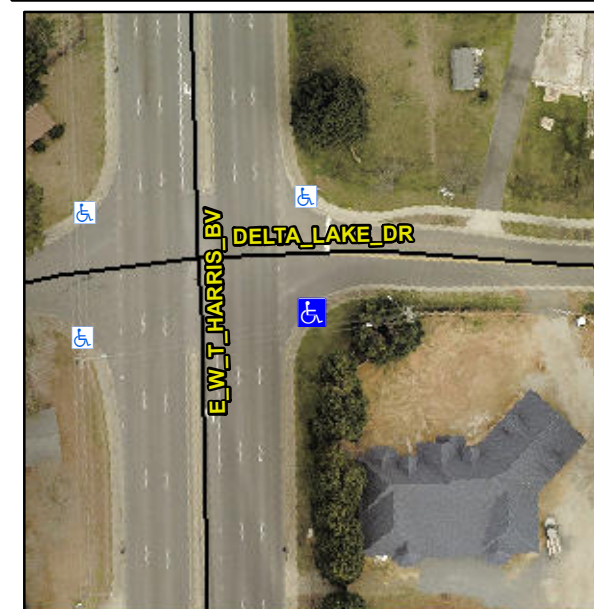
Intersection ID: 9448	Main Street: DELTA LAKE DR	Cross Street: E W T HARRIS BV	Location: SE
ADA ID: F511B75C17D3	Ramp Type: PerpDiag	Initial Pass/Fail: Fail	Overall Compliance: No
Severity Score: 12.5			
Codes/Mitigation Info/Possible Solution		Field Measurements/Component Compliance

Compliance	Description	Data	Compliance	Description	Data
N/A	Ramp Length (in)	61.0	No	Ramp Slope (%)	9.3
Yes	Ramp Width (in)	48.0	Yes	Ramp XSlope (%)	0.6
N/A	Flare Type LT	N/A	N/A	Flare Type RT	N/A
N/A	Flare Slope LT (%)	N/A	N/A	Flare Slope RT (%)	N/A
N/A	Flare Traversable LT?	N/A	N/A	Flare Traversable RT?	N/A
N/A	Landing Length (in)	N/A	N/A	DWS Provided?	N/A
N/A	Landing Width (in)	N/A	N/A	DWS Contrast?	N/A
N/A	Landing Slope (%)	N/A	N/A	DWS Length (in)	N/A
N/A	Landing X Slope (%)	N/A	N/A	DWS Full Width?	N/A
N/A	Landing Curb? (Y/N)	N/A	N/A	DWS Offset (in)	N/A
N/A	Shared Landing?	N/A			
N/A	Gutter Ponding?	N/A	N/A	Gutter Slope (%)	N/A
N/A	Gutter Lip Ht (in)	N/A	N/A	Gutter X Slope (%)	N/A
N/A	Painted X Walk1?	No	N/A	Painted X Walk2?	No
	X Walk 1 Direction	To N		X Walk 2 Direction	To W
N/A	X Walk 1 Width (in)	N/A	N/A	X Walk 2 Width (in)	N/A
	X Walk 1 Slope (%)	2.5		X Walk 2 Slope (%)	2.5
	X Walk 1 X Slope (%)	1.4		X Walk 2 X Slope (%)	1.2

N/A	Ramp inside XWalk1?	N/A	N/A	Ramp inside XWalk2?	N/A
	Road Slope (%)	0.8	N/A	Clear Space?	N/A
	Road X Slope (%)	3.6	N/A	Clear Space to XWalk (in)	N/A
N/A	Any Obstructions?	N/A	N/A	Storm Grate/Utility Hazard?	N/A
	Obstruction Type			Storm Grate/Utility Type	
		N/A			N/A
		Yes		Surface Condition? (G/P)	Good

Possible Solutions:

Remove & Replace Curb Ramp With Two New Directional Ramps or Equivalent.

Not Found, R304.2.2

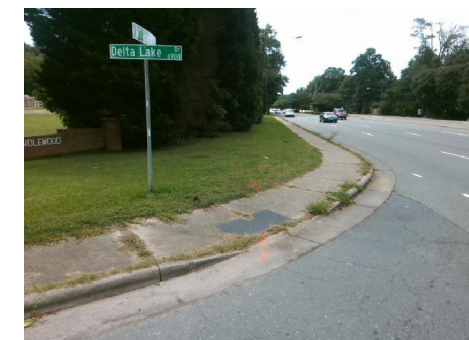
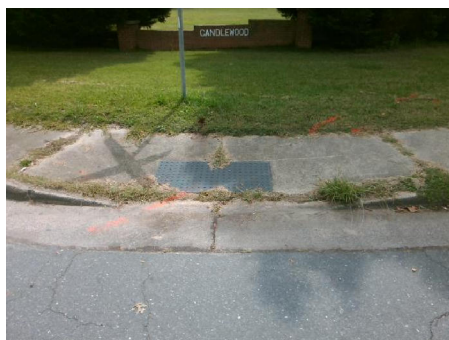
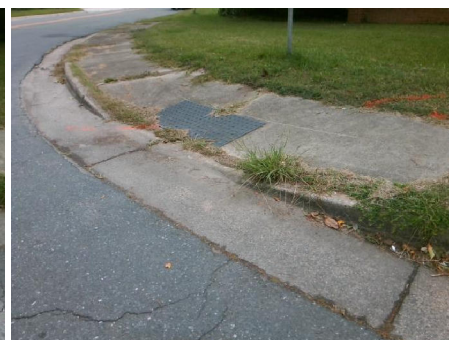
Street 1 Name DELTA LAKE DR
 Stop Condition-Street 2 StopSign
 Street 2 Name E W T HARRIS BV
 Stop Condition-Street 1 None
