Access Compliance Report

Public Rights-of-Way

(Curb Ramps)

Intersection ID: 44723	Main Street: PROSPERITY_CHURCH_RD	Cross Street: JOHNSTON_OEHLER_RD	Location: SE
ADA ID: F518FA8B9907	Ramp Type: IslandPerp	Initial Pass/Fail: Fail	Overall Compliance: No
		Severity Score: 25

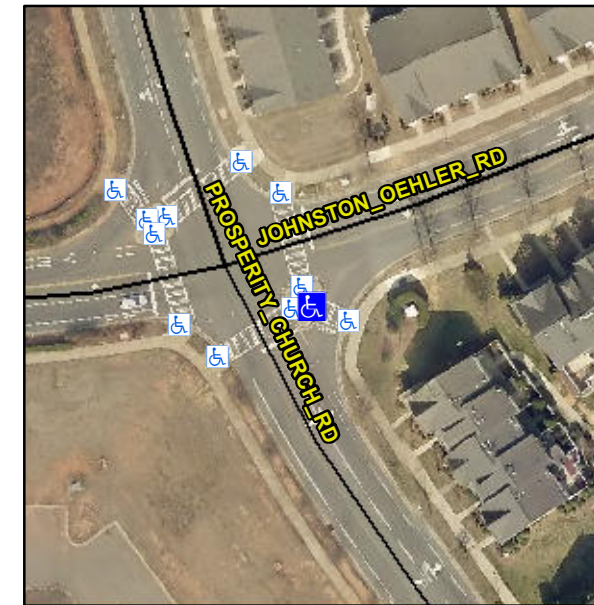
Compliance	Description	Data	Compliance	Description	Data
N/A	Ramp Length (in)	60.0	No	Ramp Slope (%)	12.5
Yes	Ramp Width (in)	77.0	Yes	Ramp XSlope (%)	0.6
N/A	Flare Type LT	N/A	N/A	Flare Type RT	N/A
N/A	Flare Slope LT (%)	N/A	N/A	Flare Slope RT (%)	N/A
N/A	Flare Traversable LT?	N/A	N/A	Flare Traversable RT?	N/A
N/A	Landing Length (in)	N/A	N/A	DWS Provided?	N/A
N/A	Landing Width (in)	N/A	N/A	DWS Contrast?	N/A
N/A	Landing Slope (%)	N/A	N/A	DWS Length (in)	N/A
N/A	Landing X Slope (%)	N/A	N/A	DWS Full Width?	N/A
N/A	Landing Curb? (Y/N)	N/A	N/A	DWS Offset (in)	N/A
N/A	Shared Landing?	N/A			
N/A	Gutter Ponding?	N/A	N/A	Gutter Slope (%)	N/A
N/A	Gutter Lip Ht (in)	N/A	N/A	Gutter X Slope (%)	N/A
N/A	Painted X Walk1?	Yes	N/A	Painted X Walk2?	N/A
	X Walk 1 Direction	To SE		X Walk 2 Direction	N/A
N/A	X Walk 1 Width (in)	112.0	N/A	X Walk 2 Width (in)	N/A
	X Walk 1 Slope (%)	2.0		X Walk 2 Slope (%)	N/A
	X Walk 1 X Slope (%)	1.6		X Walk 2 X Slope (%)	N/A

N/A	Ramp inside XWalk1?	Yes	N/A	Ramp inside XWalk2?	N/A
	Road Slope (%)	N/A	N/A	Clear Space?	N/A
	Road X Slope (%)	N/A	N/A	Clear Space to XWalk (in)	N/A
N/A	Any Obstructions?	N/A	N/A	Storm Grate/Utility Hazard?	N/A
	Obstruction Type			Storm Grate/Utility Type	
		N/A			N/A
			Yes	Surface Condition? (G/P)	Good

Remove & Replace Entire Ramp.

R304.2.2

\$ 3400.00
