Access Compliance Report

Public Rights-of-Way

(Curb Ramps)

Intersection ID: 5468	Main Street: N_TRYON_ST	Cross Street: J_W_CLAY_BV	Location: S
ADA ID: F51AC7ED2709	Ramp Type: Perp	Initial Pass/Fail: Fail	Overall Compliance: No
Severity Score: 35			
Codes/Mitigation Info/Possible Solution		Field Measurements/Component Compliance

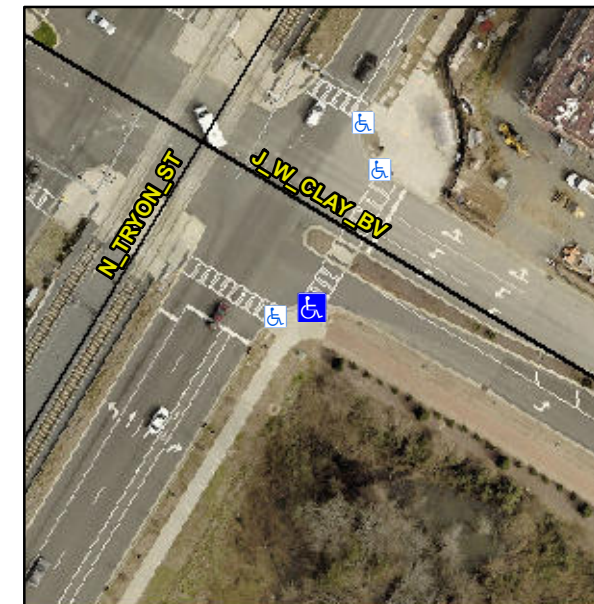
R304.5.1, R304.2.2

Compliance	Description	Data	Compliance	Description	Data
N/A	Ramp Length (in)	98.0	No	Ramp Slope (%)	20.0
No	Ramp Width (in)	46.0	Yes	Ramp XSlope (%)	3.4
N/A	Flare Type LT	N/A	N/A	Flare Type RT	N/A
N/A	Flare Slope LT (%)	N/A	N/A	Flare Slope RT (%)	N/A
N/A	Flare Traversable LT?	N/A	N/A	Flare Traversable RT?	N/A
N/A	Landing Length (in)	N/A	N/A	DWS Provided?	N/A
N/A	Landing Width (in)	N/A	N/A	DWS Contrast?	N/A
N/A	Landing Slope (%)	N/A	N/A	DWS Length (in)	N/A
N/A	Landing X Slope (%)	N/A	N/A	DWS Full Width?	N/A
N/A	Landing Curb? (Y/N)	N/A	N/A	DWS Offset (in)	N/A
N/A	Shared Landing?	N/A			
N/A	Gutter Ponding?	N/A	N/A	Gutter Slope (%)	N/A
N/A	Gutter Lip Ht (in)	1.0	N/A	Gutter X Slope (%)	N/A
N/A	Painted X Walk1?	No	N/A	Painted X Walk2?	N/A
	X Walk 1 Direction	To NE		X Walk 2 Direction	N/A
N/A	X Walk 1 Width (in)	N/A	N/A	X Walk 2 Width (in)	N/A
	X Walk 1 Slope (%)	4.0		X Walk 2 Slope (%)	N/A
	X Walk 1 X Slope (%)	5.2		X Walk 2 X Slope (%)	N/A

N/A	Ramp inside XWalk1?	N/A	N/A	Ramp inside XWalk2?	N/A
	Road Slope (%)	N/A	N/A	Clear Space?	N/A
	Road X Slope (%)	N/A	N/A	Clear Space to XWalk (in)	N/A
N/A	Any Obstructions?	N/A	N/A	Storm Grate/Utility Hazard?	N/A
	Obstruction Type			Storm Grate/Utility Type	
		N/A			N/A
		Yes		Surface Condition? (G/P)	Good

Remove & Replace Entire Ramp.
