Access Compliance Report

Public Rights-of-Way

(Curb Ramps)

Intersection ID: N/A	Main Street: IDLEWILD_RD	Cross Street: N/A	Location: NW
ADA ID: F523F7B9F4B5	Ramp Type: Directional1	Initial Pass/Fail: Fail	Overall Compliance: No
Severity Score: 12.5			
Codes/Mitigation Info/Possible Solution		Field Measurements/Component Compliance

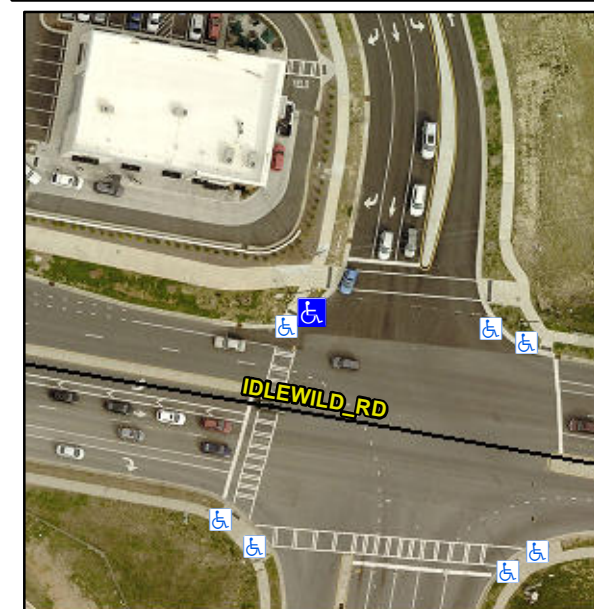
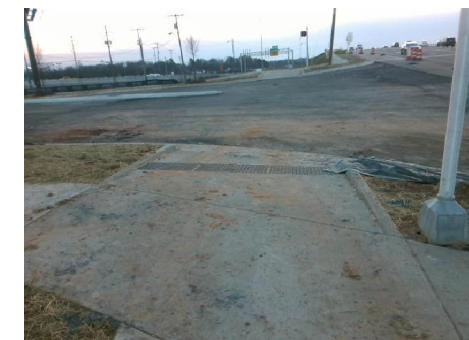
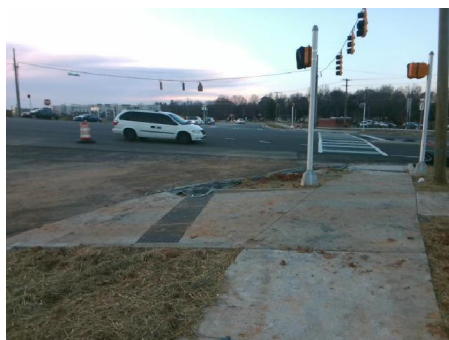
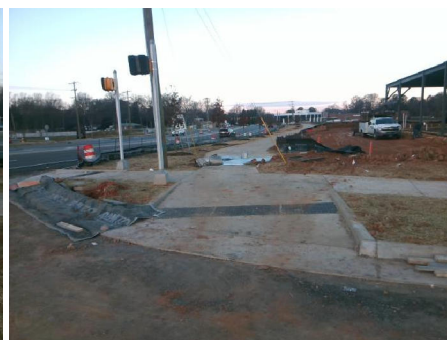
Compliance	Description	Data	Compliance	Description	Data
N/A	Ramp Length (in)	60.0	N/A	Grade Break?	N/A
Yes	Ramp Width (in)	134.0	N/A	Grade Break Slope (%)	0.0
Yes	Ramp Slope (%)	6.2	N/A	Grade Break XSlope (%)	0.0
No	Ramp XSlope (%)	5.3			
N/A	Flare Type LT	N/A	N/A	Flare Type RT	N/A
N/A	Flare Slope LT (%)	N/A	N/A	Flare Slope RT (%)	0.0
N/A	Flare Traversable LT?	N/A	N/A	Flare Traversable RT?	N/A
N/A	Landing Length (in)	0.0	N/A	DWS Provided?	N/A
N/A	Landing Width (in)	0.0	N/A	DWS Contrast?	N/A
N/A	Landing Slope (%)	0.0	N/A	DWS Length (in)	N/A
N/A	Landing X Slope (%)	0.0	N/A	DWS Full Width?	N/A
N/A	Landing Curb? (Y/N)	N/A	N/A	DWS Offset LT (in)	N/A
N/A	Shared Landing?	N/A	N/A	DWS Offset RT (in)	N/A
N/A	Gutter Ponding?	0.0	N/A	Gutter Slope (%)	N/A
N/A	Gutter Lip Ht (in)	0.0	N/A	Gutter X Slope (%)	N/A
N/A	Painted X Walk1?	No		Road Slope (%)	5.2
	X Walk 1 Direction	To E		Road X Slope (%)	0.6
	X Walk 1 Width (in)	N/A		Clear Space?	N/A

X Walk 1 Slope (%)	5.2	N/A	Clear Space to XWalk (in)	N/A
	X Walk 1 X Slope (%)	0.6	N/A	Storm Grate/Utility Hazard?	N/A
N/A	Ramp inside XWalk1?	N/A		Storm Grate/Utility Type	
N/A	Any Obstructions?	N/A			N/A
	Obstruction Type		Yes	Surface Condition? (G/P)	Good
			N/A	Curb Slope (%)	6.2

Possible Solutions:

Remove & Replace Entire Ramp.
