Access Compliance Report Public Rights-of-Way (Curb Ramps)

Intersection ID: 13283 Main Street: SOUTHWOOD AV **Cross Street: W SUMMIT AV** Location: W **ADA ID: F53D9B9EA559** Ramp Type: BlendTrans2 Initial Pass/Fail: Fail **Overall Compliance: No** Severity Score: 18.75

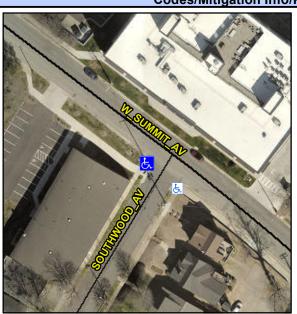
PROW/ADA: Not Found, R304.5.1, R304.5.3

Data	Compliance Description		Data
N/A	Ramp Length (in)	112.0	Yes	BlendTrans Slope (%)	1.1
No	Ramp Width (in)	32.0	No	BlendTrans XSlope (%)	3.3
N/A	Flare Type LT	N/A	N/A	Flare Type RT	N/A
N/A	Flare Slope LT (%)	N/A	N/A	Flare Slope RT (%)	N/A
N/A	Flare Traversable LT?	N/A	N/A	Flare Traversable RT?	N/A
N/A	Landing Length (in)	N/A	N/A	DWS Provided?	N/A
N/A	Landing Width (in)	N/A	N/A	DWS Contrast?	N/A
N/A	Landing Slope (%)	N/A	N/A	DWS Length (in)	N/A
N/A	Landing X Slope (%)	N/A	N/A	DWS Full Width?	N/A
N/A	Landing Curb? (Y/N)	N/A	N/A	DWS Offset (in)	N/A
N/A	Shared Landing?	N/A			
N/A	Gutter Ponding?	N/A	N/A	Gutter Slope (%)	N/A
N/A	Gutter Lip Ht (in)	N/A	N/A	Gutter X Slope (%)	N/A
N/A	Painted X Walk1?	No	N/A	Painted X Walk2?	No
	X Walk 1 Direction	To NE		X Walk 2 Direction	To SE
	X Walk 1 Width (in)	N/A		X Walk 2 Width (in)	N/A
	X Walk 1 Slope (%)	6.7		X Walk 2 Slope (%)	2.7
	X Walk 1 X Slope (%)	2.8		X Walk 2 X Slope (%)	8.5

N/A	Ramp inside XWalk1?	N/A	N/A	Ramp inside XWalk2?	N/A
	Road Slope (%)	1.3		Clear Space?	N/A
	Road X Slope (%)	6.8	N/A	Clear Space to XWalk (in)	N/A
N/A	Any Obstructions?	N/A	N/A	Storm Grate/Utility Hazard?	N/A
	Obstruction Type			Storm Grate/Utility Type	
		N/A			N/A
			Yes	Surface Condition? (G/P)	Good
			No	Curb Slope (%)	22.8

Possible Solutions: Remove & Replace Curb Ramp With Two New Directional Ramps or Equivalent. Surveyor Notes: N/A
