# Access Compliance Report

### (Curb Ramps)

| Intersection ID: 18797 | Main Street: SENECA_PL | Cross Street: WEDGEWOOD_DR | Location: SW |
| ADA ID: F542923E9A4C | Ramp Type: Perp | Initial Pass/Fail: Fail | Overall Compliance: No |

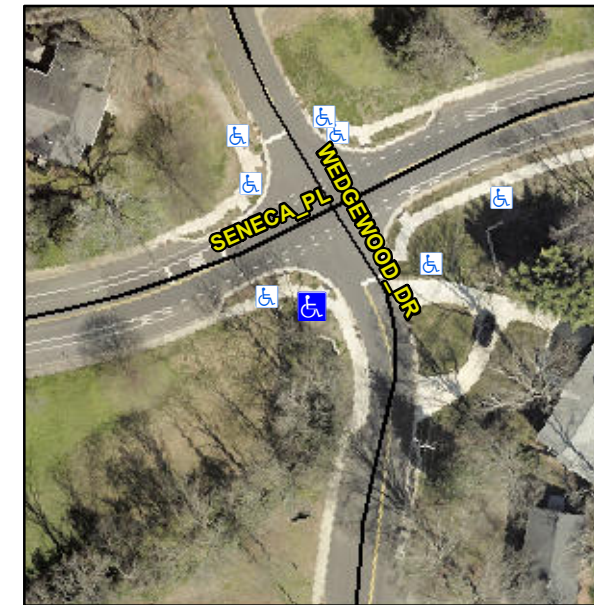
| | | Severity Score: 12.5 | |

**Not Found, R304.5.3**

| Compliance | Description | Data | Compliance | Description | Data |
|---|---|---|---|---|---|
| N/A | Ramp Length (in) | 61.0 | Yes | Ramp Slope (%) | 7.4 |
| Yes | Ramp Width (in) | 72.0 | No | Ramp XSlope (%) | 5.4 |

**Remove & Replace Entire Ramp.**

Total Cost: \$ 1850.00
