Access Compliance Report

Public Rights-of-Way

(Curb Ramps)

Intersection ID: 50942	Main Street: CEDAR_WALK_LN	Cross Street: DUNAVERTY_PL	Location: SE
ADA ID: F54A8138FFDB	Ramp Type: PerpDiag	Initial Pass/Fail: Fail	Overall Compliance: No
Severity Score: 35			
Codes/Mitigation Info/Possible Solution		Field Measurements/Component Compliance

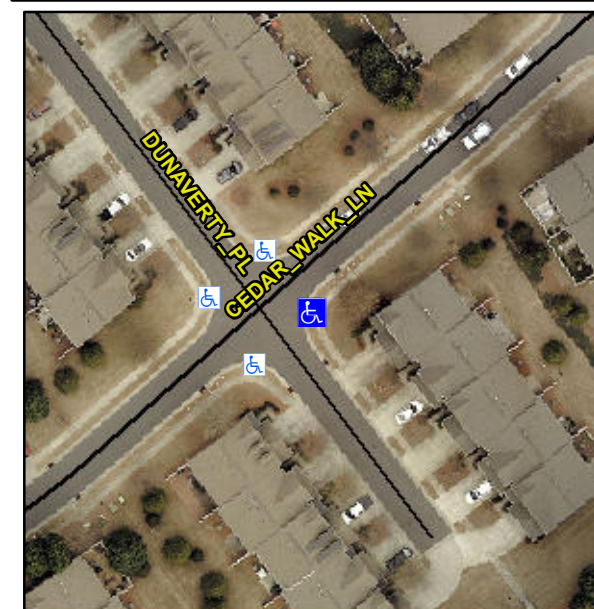
Not Found, R304.5.1, R304.2.2, R304.5.3

Compliance	Description	Data	Compliance	Description	Data
N/A	Ramp Length (in)	47.0	No	Ramp Slope (%)	12.2
No	Ramp Width (in)	47.0	No	Ramp XSlope (%)	4.2
N/A	Flare Type LT	N/A	N/A	Flare Type RT	N/A
N/A	Flare Slope LT (%)	N/A	N/A	Flare Slope RT (%)	N/A
N/A	Flare Traversable LT?	N/A	N/A	Flare Traversable RT?	N/A
N/A	Landing Length (in)	N/A	N/A	DWS Provided?	N/A
N/A	Landing Width (in)	N/A	N/A	DWS Contrast?	N/A
N/A	Landing Slope (%)	N/A	N/A	DWS Length (in)	N/A
N/A	Landing X Slope (%)	N/A	N/A	DWS Full Width?	N/A
N/A	Landing Curb? (Y/N)	N/A	N/A	DWS Offset (in)	N/A
N/A	Shared Landing?	N/A			
N/A	Gutter Ponding?	N/A	N/A	Gutter Slope (%)	N/A
N/A	Gutter Lip Ht (in)	N/A	N/A	Gutter X Slope (%)	N/A
N/A	Painted X Walk1?	No	N/A	Painted X Walk2?	No
	X Walk 1 Direction	To NW		X Walk 2 Direction	To SW
N/A	X Walk 1 Width (in)	N/A	N/A	X Walk 2 Width (in)	N/A
	X Walk 1 Slope (%)	1.6		X Walk 2 Slope (%)	0.6
	X Walk 1 X Slope (%)	1.9		X Walk 2 X Slope (%)	0.3

N/A	Ramp inside XWalk1?	N/A	N/A	Ramp inside XWalk2?	N/A
	Road Slope (%)	1.7	N/A	Clear Space?	N/A
	Road X Slope (%)	1.2	N/A	Clear Space to XWalk (in)	N/A
N/A	Any Obstructions?	N/A	N/A	Storm Grate/Utility Hazard?	N/A
	Obstruction Type			Storm Grate/Utility Type	
		N/A			N/A
			Yes	Surface Condition? (G/P)	Good

Possible Solutions:

Remove & Replace Curb Ramp With Two New Directional Ramps or Equivalent.
