# Access Compliance Report

## Public Rights-of-Way

### (Curb Ramps)

Intersection ID: 6977	Main Street: MCALLISTER_DR	Cross Street: CLIPPARD_CT	Location: SE
ADA ID: F54C8EFAB36B	Ramp Type: Perp	Initial Pass/Fail: Fail	Overall Compliance: No
Severity Score: 12.5			
Codes/Mitigation Info/Possible Solution		Field Measurements/Component Compliance

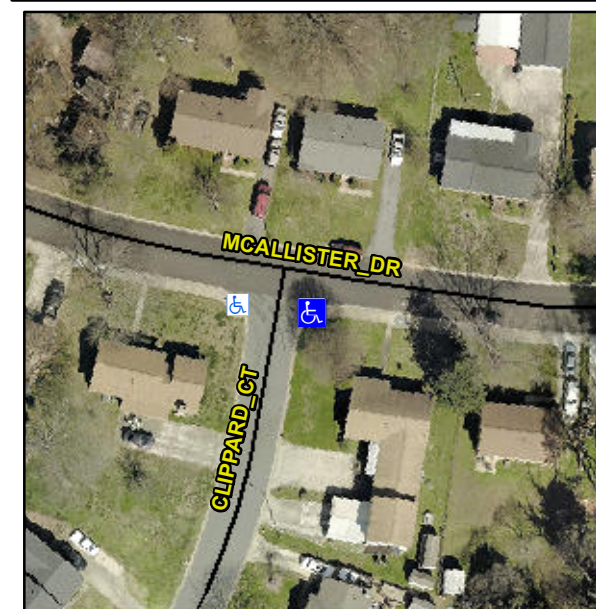
**Not Found, R304.5.3**

Compliance	Description	Data	Compliance	Description	Data
N/A	Ramp Length (in)	28.0	Yes	Ramp Slope (%)	7.6
Yes	Ramp Width (in)	48.0	No	Ramp XSlope (%)	5.7
N/A	Flare Type LT	N/A	N/A	Flare Type RT	N/A
N/A	Flare Slope LT (%)	N/A	N/A	Flare Slope RT (%)	N/A
N/A	Flare Traversable LT?	N/A	N/A	Flare Traversable RT?	N/A
N/A	Landing Length (in)	N/A	N/A	DWS Provided?	N/A
N/A	Landing Width (in)	N/A	N/A	DWS Contrast?	N/A
N/A	Landing Slope (%)	N/A	N/A	DWS Length (in)	N/A
N/A	Landing X Slope (%)	N/A	N/A	DWS Full Width?	N/A
N/A	Landing Curb? (Y/N)	N/A	N/A	DWS Offset (in)	N/A
N/A	Shared Landing?	N/A			
N/A	Gutter Ponding?	N/A	N/A	Gutter Slope (%)	N/A
N/A	Gutter Lip Ht (in)	N/A	N/A	Gutter X Slope (%)	N/A
N/A	Painted X Walk1?	No	N/A	Painted X Walk2?	N/A
	X Walk 1 Direction	To W		X Walk 2 Direction	N/A
N/A	X Walk 1 Width (in)	N/A	N/A	X Walk 2 Width (in)	N/A
	X Walk 1 Slope (%)	3.2		X Walk 2 Slope (%)	N/A
	X Walk 1 X Slope (%)	4.1		X Walk 2 X Slope (%)	N/A

N/A	Ramp inside XWalk1?	N/A	N/A	Ramp inside XWalk2?	N/A
	Road Slope (%)	N/A	N/A	Clear Space?	N/A
	Road X Slope (%)	N/A	N/A	Clear Space to XWalk (in)	N/A
N/A	Any Obstructions?	N/A	N/A	Storm Grate/Utility Hazard?	N/A
	Obstruction Type			Storm Grate/Utility Type	
		N/A			N/A
		Yes		Surface Condition? (G/P)	Good

**Remove & Replace Entire Ramp.**

Total Cost: \$ 1850.00
