Access Compliance Report

Public Rights-of-Way

(Curb Ramps)

Intersection ID: 43523	Main Street: WIND_CHIME_CT	Cross Street: MISTRAL_WY	Location:	W
ADA ID: F55679248996	Ramp Type: BlendTrans1	Initial Pass/Fail: Fail	Overall Compliance: No	Severity Score: 10

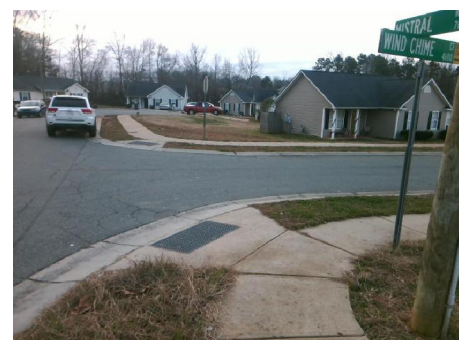
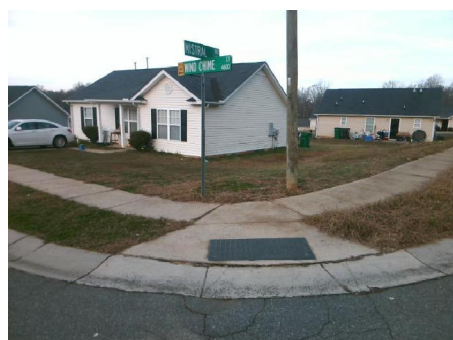
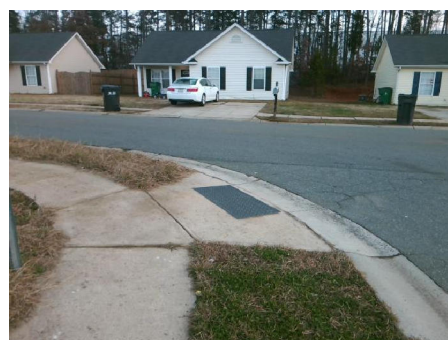
CURB LIP 0.5

Not Found, R304.5.1, R304.5.3

Compliance	Description	Data	Compliance	Description	Data
N/A	Ramp Length (in)	50.0	Yes	BlendTrans Slope (%)	4.4
No	Ramp Width (in)	47.5	No	BlendTrans XSlope (%)	4.7
N/A	Flare Type LT	N/A	N/A	Flare Type RT	N/A
N/A	Flare Slope LT (%)	N/A	N/A	Flare Slope RT (%)	N/A
N/A	Flare Traversable LT?	N/A	N/A	Flare Traversable RT?	N/A
N/A	Landing Length (in)	N/A	N/A	DWS Provided?	N/A
N/A	Landing Width (in)	N/A	N/A	DWS Contrast?	N/A
N/A	Landing Slope (%)	N/A	N/A	DWS Length (in)	N/A
N/A	Landing X Slope (%)	N/A	N/A	DWS Full Width?	N/A
N/A	Landing Curb? (Y/N)	N/A	N/A	DWS Offset (in)	N/A
N/A	Shared Landing?	N/A			
N/A	Gutter Ponding?	N/A	N/A	Gutter Slope (%)	N/A
N/A	Gutter Lip Ht (in)	N/A	N/A	Gutter X Slope (%)	N/A
N/A	Painted X Walk1?	No	N/A	Painted X Walk2?	No
	X Walk 1 Direction	To SE		X Walk 2 Direction	To NE
	X Walk 1 Width (in)	N/A		X Walk 2 Width (in)	N/A
	X Walk 1 Slope (%)	1.5		X Walk 2 Slope (%)	2.9
	X Walk 1 X Slope (%)	4.7		X Walk 2 X Slope (%)	1.5

N/A	Ramp inside XWalk1?	N/A	N/A	Ramp inside XWalk2?	N/A
	Road Slope (%)	5.6		Clear Space?	N/A
	Road X Slope (%)	3.8	N/A	Clear Space to XWalk (in)	N/A
N/A	Any Obstructions?	N/A	N/A	Storm Grate/Utility Hazard?	N/A
	Obstruction Type			Storm Grate/Utility Type	
		N/A			N/A
			Yes	Surface Condition? (G/P)	Good
			No	Curb Slope (%)	6.7

Remove & Replace Curb Ramp With Two New Directional Ramps or Equivalent.
