# Access Compliance Report

## Public Rights-of-Way

### (Curb Ramps)

Intersection ID: 42932	Main Street: CARNSORE_CT	Cross Street: HOLLY_PARK_DR	Location: S
ADA ID: F556F19852F8	Ramp Type: PerpDiag	Initial Pass/Fail: Fail	Overall Compliance: No
Codes/Mitigation Info/Possible Solution		Field Measurements/Component Compliance	
Severity Score: 46.25

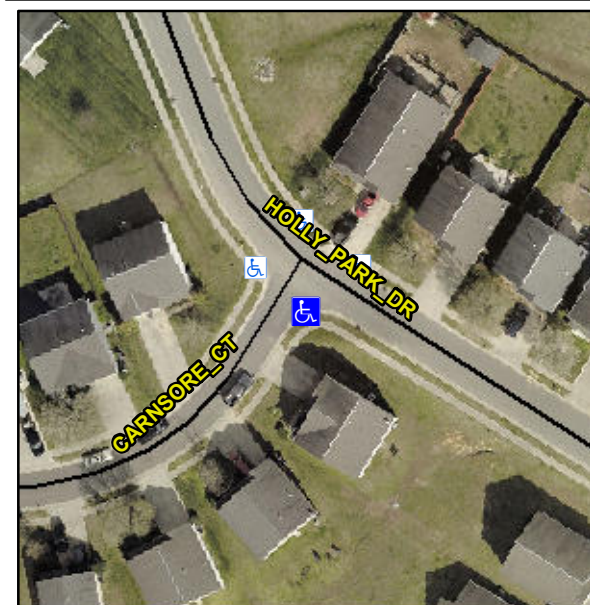
**Not Found, R304.5.1, R304.2.2, R304.5.3**

Compliance	Description	Data	Compliance	Description	Data
N/A	Ramp Length (in)	48.0	No	Ramp Slope (%)	10.1
No	Ramp Width (in)	40.0	No	Ramp XSlope (%)	10.3
N/A	Flare Type LT	N/A	N/A	Flare Type RT	N/A
N/A	Flare Slope LT (%)	N/A	N/A	Flare Slope RT (%)	N/A
N/A	Flare Traversable LT?	N/A	N/A	Flare Traversable RT?	N/A
N/A	Landing Length (in)	N/A	N/A	DWS Provided?	N/A
N/A	Landing Width (in)	N/A	N/A	DWS Contrast?	N/A
N/A	Landing Slope (%)	N/A	N/A	DWS Length (in)	N/A
N/A	Landing X Slope (%)	N/A	N/A	DWS Full Width?	N/A
N/A	Landing Curb? (Y/N)	N/A	N/A	DWS Offset (in)	N/A
N/A	Shared Landing?	N/A			
N/A	Gutter Ponding?	N/A	N/A	Gutter Slope (%)	N/A
N/A	Gutter Lip Ht (in)	N/A	N/A	Gutter X Slope (%)	N/A
N/A	Painted X Walk1?	No	N/A	Painted X Walk2?	No
	X Walk 1 Direction	To NE		X Walk 2 Direction	To NW
N/A	X Walk 1 Width (in)	N/A	N/A	X Walk 2 Width (in)	N/A
	X Walk 1 Slope (%)	4.4		X Walk 2 Slope (%)	3.3
	X Walk 1 X Slope (%)	5.2		X Walk 2 X Slope (%)	6.7

N/A	Ramp inside XWalk1?	N/A	N/A	Ramp inside XWalk2?	N/A
	Road Slope (%)	6.8	N/A	Clear Space?	N/A
	Road X Slope (%)	0.2	N/A	Clear Space to XWalk (in)	N/A
N/A	Any Obstructions?	N/A	N/A	Storm Grate/Utility Hazard?	N/A
	Obstruction Type			Storm Grate/Utility Type	
		N/A			N/A
			Yes	Surface Condition? (G/P)	Good

**Remove & Replace Curb Ramp With Two New Directional Ramps or Equivalent.**

Total Cost: \$ 3200.00
