# Access Compliance Report

## Public Rights-of-Way

### (Curb Ramps)

| Intersection ID: 12455 | Main Street: W_3RD_ST | Cross Street: S_TRYON_ST | Location: W |

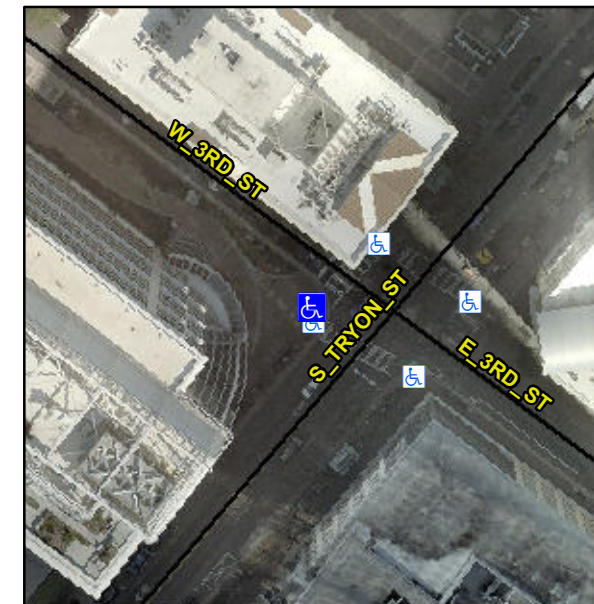
| ADA ID: F56374BDBFBC | Ramp Type: Perp | Initial Pass/Fail: Fail | Overall Compliance: No |
| | | Severity Score: 22.5 | |

**R304.5.1, R304.2.2, R304.5.3**

| Compliance | Description | Data | Compliance | Description | Data |
|---|---|---|---|---|---|
| N/A | Ramp Length (in) | 24.0 | No | Ramp Slope (%) | 9.0 |
| No | Ramp Width (in) | 41.0 | No | Ramp XSlope (%) | 2.2 |

**Remove & Replace Entire Ramp.**

Total Cost: \$ 1850.00
