Access Compliance Report

Public Rights-of-Way

(Curb Ramps)

Intersection ID: 45776	Main Street: CRABAPPLE_TREE_LN	Cross Street: CARVER_FALLS_RD	Location: S
ADA ID: F5676ED660C3	Ramp Type: Perp	Initial Pass/Fail: Fail	Overall Compliance: No
Severity Score: 8.75			
Codes/Mitigation Info/Possible Solution		Field Measurements/Component Compliance

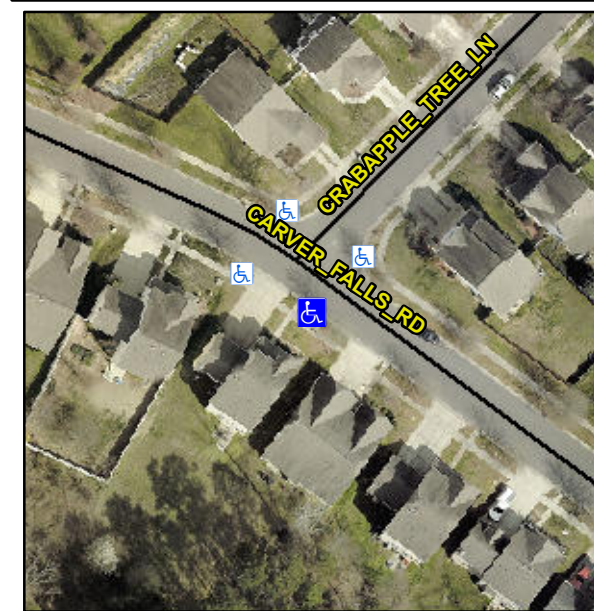
Not Found, R304.5.1

Compliance	Description	Data	Compliance	Description	Data
N/A	Ramp Length (in)	70.5	Yes	Ramp Slope (%)	5.0
No	Ramp Width (in)	47.0	Yes	Ramp XSlope (%)	1.3
N/A	Flare Type LT	N/A	N/A	Flare Type RT	N/A
N/A	Flare Slope LT (%)	N/A	N/A	Flare Slope RT (%)	N/A
N/A	Flare Traversable LT?	N/A	N/A	Flare Traversable RT?	N/A
N/A	Landing Length (in)	N/A	N/A	DWS Provided?	N/A
N/A	Landing Width (in)	N/A	N/A	DWS Contrast?	N/A
N/A	Landing Slope (%)	N/A	N/A	DWS Length (in)	N/A
N/A	Landing X Slope (%)	N/A	N/A	DWS Full Width?	N/A
N/A	Landing Curb? (Y/N)	N/A	N/A	DWS Offset (in)	N/A
N/A	Shared Landing?	N/A			
N/A	Gutter Ponding?	N/A	N/A	Gutter Slope (%)	N/A
N/A	Gutter Lip Ht (in)	N/A	N/A	Gutter X Slope (%)	N/A
N/A	Painted X Walk1?	No	N/A	Painted X Walk2?	N/A
	X Walk 1 Direction	To NE		X Walk 2 Direction	N/A
N/A	X Walk 1 Width (in)	N/A	N/A	X Walk 2 Width (in)	N/A
	X Walk 1 Slope (%)	2.1		X Walk 2 Slope (%)	N/A
	X Walk 1 X Slope (%)	1.1		X Walk 2 X Slope (%)	N/A

N/A	Ramp inside XWalk1?	N/A	N/A	Ramp inside XWalk2?	N/A
	Road Slope (%)	N/A	N/A	Clear Space?	N/A
	Road X Slope (%)	N/A	N/A	Clear Space to XWalk (in)	N/A
N/A	Any Obstructions?	N/A	N/A	Storm Grate/Utility Hazard?	N/A
	Obstruction Type			Storm Grate/Utility Type	
		N/A			N/A
			Yes	Surface Condition? (G/P)	Good

Possible Solutions:

Remove & Replace Entire Ramp.
