Access Compliance Report

Public Rights-of-Way

(Curb Ramps)

Intersection ID: 21751	Main Street: BRITTON_WOOD_PL	Cross Street: POPLAR_FOREST_DR	Location: SW
ADA ID: F573AD0C01C7	Ramp Type: PerpDiag	Initial Pass/Fail: Fail	Overall Compliance: No
Severity Score: 60			
Codes/Mitigation Info/Possible Solution		Field Measurements/Component Compliance

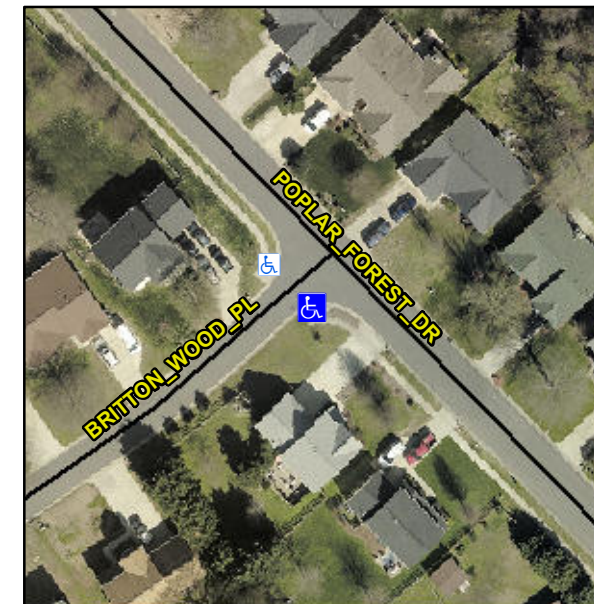
Compliance	Description	Data	Compliance	Description	Data
N/A	Ramp Length (in)	108.0	Yes	Ramp Slope (%)	8.1
No	Ramp Width (in)	31.0	No	Ramp XSlope (%)	7.7
N/A	Flare Type LT	N/A	N/A	Flare Type RT	N/A
N/A	Flare Slope LT (%)	N/A	N/A	Flare Slope RT (%)	N/A
N/A	Flare Traversable LT?	N/A	N/A	Flare Traversable RT?	N/A
N/A	Landing Length (in)	N/A	N/A	DWS Provided?	N/A
N/A	Landing Width (in)	N/A	N/A	DWS Contrast?	N/A
N/A	Landing Slope (%)	N/A	N/A	DWS Length (in)	N/A
N/A	Landing X Slope (%)	N/A	N/A	DWS Full Width?	N/A
N/A	Landing Curb? (Y/N)	N/A	N/A	DWS Offset (in)	N/A
N/A	Shared Landing?	N/A			
N/A	Gutter Ponding?	N/A	N/A	Gutter Slope (%)	N/A
N/A	Gutter Lip Ht (in)	N/A	N/A	Gutter X Slope (%)	N/A
N/A	Painted X Walk1?	No	N/A	Painted X Walk2?	No
	X Walk 1 Direction	To NE		X Walk 2 Direction	To NW
N/A	X Walk 1 Width (in)	N/A	N/A	X Walk 2 Width (in)	N/A
	X Walk 1 Slope (%)	5.3		X Walk 2 Slope (%)	0.7
	X Walk 1 X Slope (%)	0.9		X Walk 2 X Slope (%)	5.9

N/A	Ramp inside XWalk1?	N/A	N/A	Ramp inside XWalk2?	N/A
	Road Slope (%)	6.1	N/A	Clear Space?	N/A
	Road X Slope (%)	1.9	N/A	Clear Space to XWalk (in)	N/A
N/A	Any Obstructions?	N/A	N/A	Storm Grate/Utility Hazard?	N/A
	Obstruction Type			Storm Grate/Utility Type	
		N/A			N/A
			Yes	Surface Condition? (G/P)	Good

Possible Solutions:

Remove & Replace Curb Ramp With Two New Directional Ramps or Equivalent.

R304.5.1, R304.5.3
